ANALYSIS OF HAGIA SOPHIA USING NONDESTRUCTIVE MEASUREMENT

TAKASHI HARA¹ and KENICHIRO HIDAKA²

In this paper, the structural behavior of Hagia Sophia was analyzed by use of vibration records of the structure. The vibration records were measured by the micro tremor meters. The recorded data was utilized not only to define the mode shape but also to evaluate the structural problems. Firstly, the vibration characteristics of the main building were analyzed by combining the vibration records. Secondary, the deformation characteristics and the structural functions of the second cornice were investigated in the same manner as the main building. In case of main building, from the frequency domain analyses, the natural frequency of the main building was analyzed and the obtained natural frequencies were compared with the results of the previous researches. The vibration modes were investigated as well. From these results, the characteristics of the total structure were clarified and the structural problems were detected. In case of the second cornice, the base at the corner where was the junction of the main pier and the sub-dome connecting to the semi-dome showed the movement of the embe

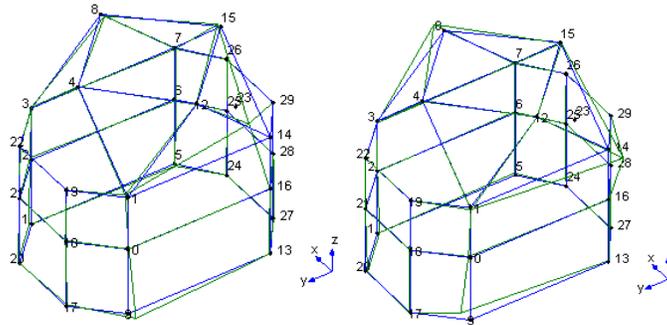
Using the FDD analysis, the frequency domain expressions of four measuring record sets were combined and represented. From the measurement, the first two frequencies 1.85Hz and 2.09Hz were obtained. These were the same results obtained by Hidaka (2004) and Çakmak (1995). 1.85Hz and 2.09Hz are natural frequency for the predominant vibration in N-S direction, respectively. However, in addition, in this analysis, the peak frequencies 2.93Hz and 3.06Hz, were obtained respectively. The vibration modes of 2.93Hz is shown in Figures 5. In case, the building at south west pier moves, even it is a column base. Çukmak (1995) reported that the southern portion of the building has deeper foundation than the northern portion. It may cause the column movement mode.

Figure 5. Vibration mode shape (2.93Hz).

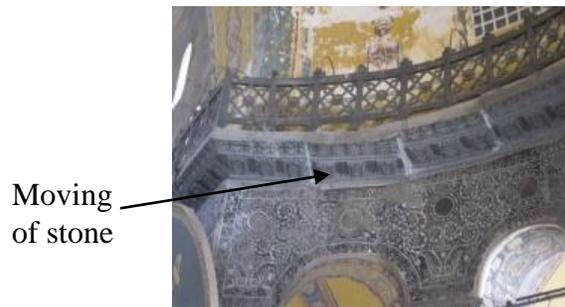
Figure 6. Problems at the south west second cornice.

Figure 6), the deformation of the second cornice and the movement of the composing stones were detected. From the observation, the same phenomena were detected at each corner of the second cornice on the main piers. There are particular deformations. Therefore, the movement of the cornice at south west corner was investigated as an example. Figure 6 shows the picture of the problem of the south western cornice.

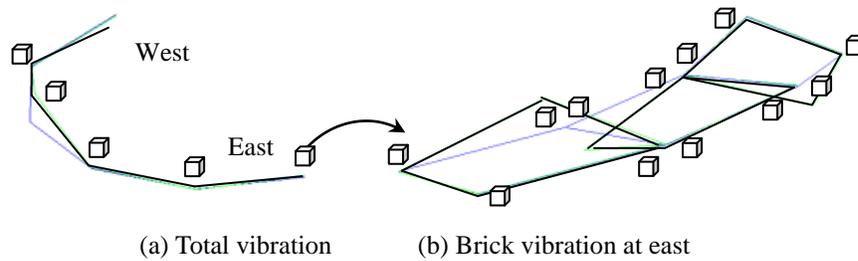
The total movement of the cornice shows large amplitude at the center with the natural frequency 9.70Hz (Figure 7(a)). Also, at the east end of the south west cornice, three stones vibrate independently with natural frequency 2.91Hz (Figure 7(b)). The movement of the stones was detected at the east end of the south west cornice.

Figure 7. Vibration of second cornice (□ tremor meter).

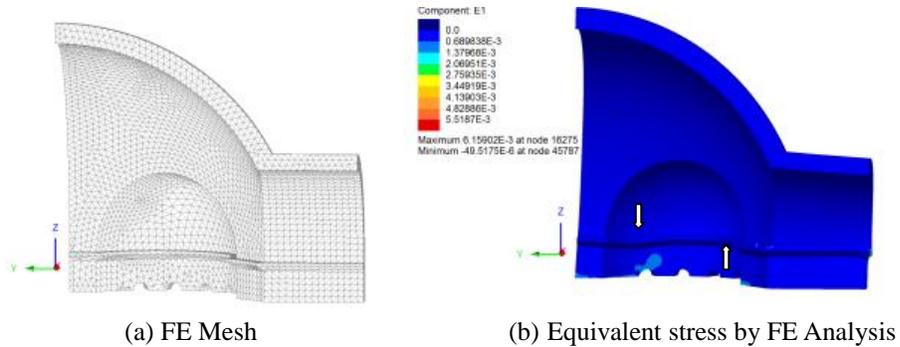
Figure 8. FEM analysis.

Considering the symmetry of N-S and EW directions, a quarter of the model was adopted. Applied load was the self weight and the lateral load on the x-z plane that was applied as the dome thrust. The boundary condition at the bottom was fixed in the vertical direction and the symmetrical boundary conditions were applied to other cutting edges. Figure 8(b) shows numerical results as well. The cornice did not deform at west end and moved upward on the western part of the cornice and sank downward on the eastern cornice. The cornice did not move at the east end by the main pier. Therefore, the cornice deforms vertically as like S shape. Also, the deformation shape was similar to the deformation obtained from the vibration mode shown in Figure 6(a). The cornice at the left end on the exedra shows higher equivalent stress (Figure 8(b)).
