REHABILITATION AND LOAD TESTING OF A BRIDGE

KAWAN G. ALANI¹ and ABDULLAH S. AHMED²

¹*Alani & AlShamma Consultancy Bureau , Baghdad, Iraq*

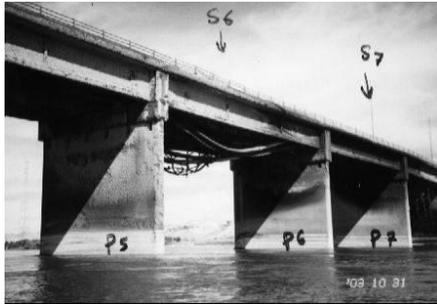
- A complete collapse of span nine.
- Large opening in the middle of the upstream carriageway of span six with heavy damage of its middle girder.
- Excessive deflection of the downstream carriageway of span eight.

- The other spans were affected to a varying degree, where the fire had caused peeling of concrete cover and the exposure of reinforcing bars. Cracking appeared in some of the main girders.

- The two abutments show only minor damages.
- Piers P1, P2 and P3 were in good conditions except for their crossheads which suffered moderate to minor damages. Piers P6, P7, P8 and P9 suffered heavy damages throughout their exposed parts above water line. While piers P4, P5 suffered moderate damages at parts above the mid height of piers.

Figure 1. Damages of bridge.

- Most of the expansion joints were damaged.
- After thorough study of the results of inspections, it was decided to replace spans six to ten and demolishing the exposed parts of piers P6, P7, P8, and P9, then rebuild them to the original design.

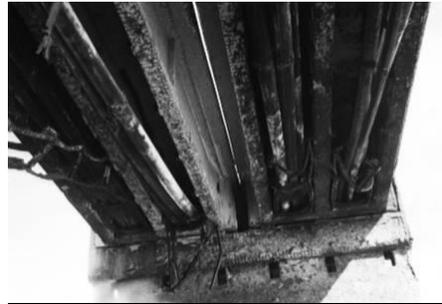
- As for the rest of the bridge parts, which mainly suffered from exposure to fire, a decision was taken to restore them to their original capacity by carrying out engineering repair work. Among these, span five being closed to span six, which was subjected to the direct attack, and hence suffered more from the fire caused by the attack. See Figure 2. Thorough inspection of span five was conducted and the state of each girder was documented. In general, the elements of the deck structure did not exhibit signs of distress, like excessive deflection and/or heavy cracking.

Figure 2. Damages of span five.

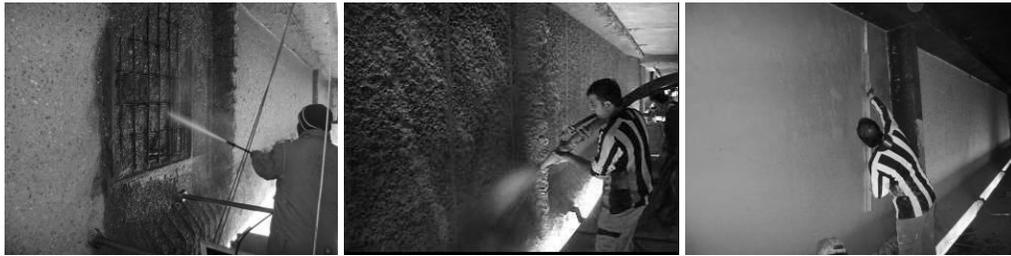
Figures 3, 4, & 5. Different stages of repair work.

- The removal of all the loose materials until a layer of sound concrete was reached.
- Then a water jet was applied to the exposed areas of concrete in order to remove the dust and the remaining loose materials, thereby leaving clean and sound surface. See Figure 3.

- The next step was to fill all visible cracks with structural quality injection material, i.e., low viscosity high strength epoxy sealing system conforming to ASTM C881 Specification. Injection material was selected and applied according to the instructions of the manufacturer. This type of material can be used to seal cracks up to 50mm width.

- After completion cracks injection work, the following task was to apply the replacement for the damaged surface layers. For this task, high quality shrinkage compensated cementitious material with polymer fiber reinforcement in order to reduce cracking, and with good bonding properties with underline concrete was chosen. A suitable material was chosen and applied by pressure sprayer. See Figure 4. Because the areas which were covered were large, they were divided to small panels by narrow guiding strips made of the same material to the required thickness. Then these panels were sprayed and troweled to the accurate level of the guiding strips. See Figure 5.

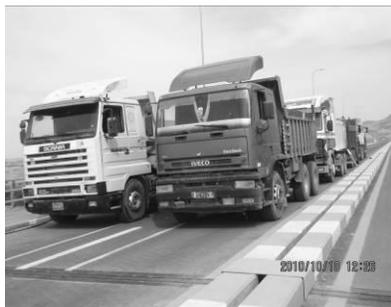
A carriageway 7.1m wide, according to BS5400-P2, consists of two notional lanes. For design purposes, either the two notional lanes are loaded with full HA load, or one lane is loaded with full HA load while the other is loaded with HB load. For an effective span for girders of 41.44m, the total span load which gives maximum deflection at mid-span was determined to be about 2000kN. To simulate the effect of this load, eight trucks were selected each weighs 250kN. See Figure 6. This load was applied in four increments; each consists of two trucks, i.e., 500kN per increment.

Figure 6. Load test (full load stage).

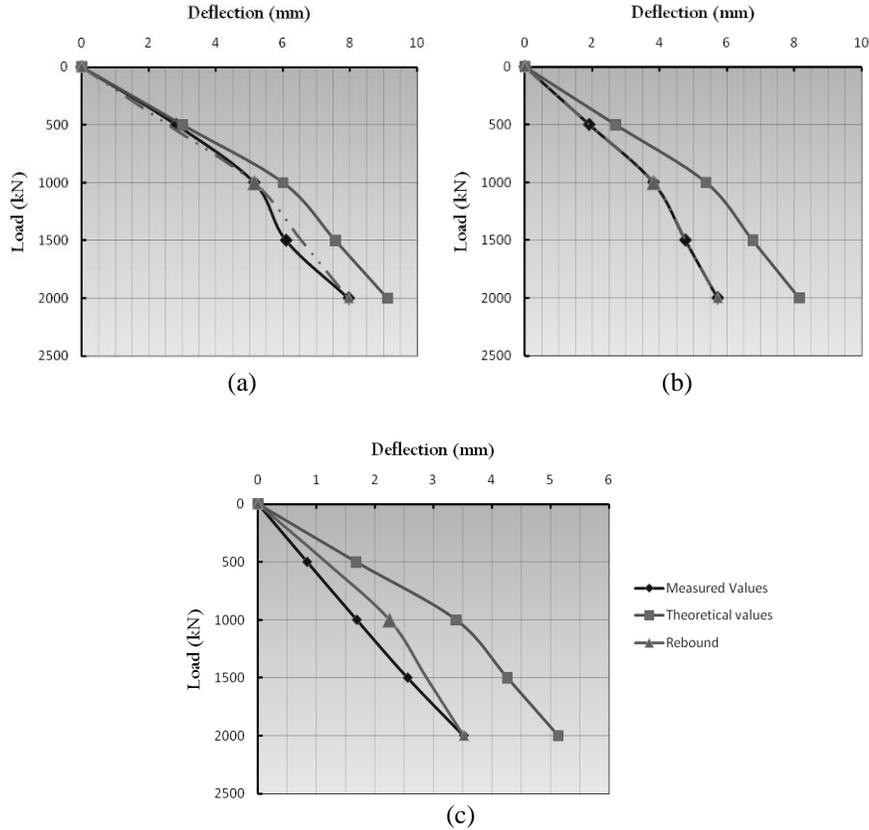
Figure 7. Load-deflection at midspan (a) girder 1. (b) girder 2. (c) girder 3.

Graphs of measured and calculated deflections at mid-span of the three girders are plotted against loading. See Figure 7. In this Figure, the theoretically calculated deflections are higher than the measured values. The graphs of measured deflections show complete recovery of deflection after removal of loading.

- The complete recovery of deflection after removal of the applied load means that the deck structure was acting in the elastic range of the material (elastic behavior).
- The measured maximum deflections of girders are smaller than the calculated values for the same loading conditions may be attributed to that the approximation used in the modeling of the structure is on the conservative side and that the repair material properties are appreciably higher than the concrete used in the original structure, i.e., the repair material has little bit higher modulus of elasticity (E_c).
