# VIBRATION PROPERTIES OF TRADITIONAL MASONRY WALLS OF CORTES CHURCH

The Santo Niño Church in Bohol Island was partially damaged in the Bohol Earthquake in October 2013. In this study, we investigated the structural property of the Santo Niño Church to understand the vibration characteristics of Philippine masonry constructions by checking the main damage and conducting measurement surveys and microtremor measurement on the structure and ground. The major findings of this study can be summarized as follows: (a) Collapsed walls, peeling wall stone, corner deformation, and collapsed ceiling were the main damages that were observed. The collapsed wall was measured, and the make-up and material thickness of the wall was verified. (b) By performing microtremor measurements on the walls, the vibration property of the church, such as the natural frequency and vibration mode of the longest wall A was clarified. The 1<sup>st</sup> natural frequency of the longest wall A is the lowest.

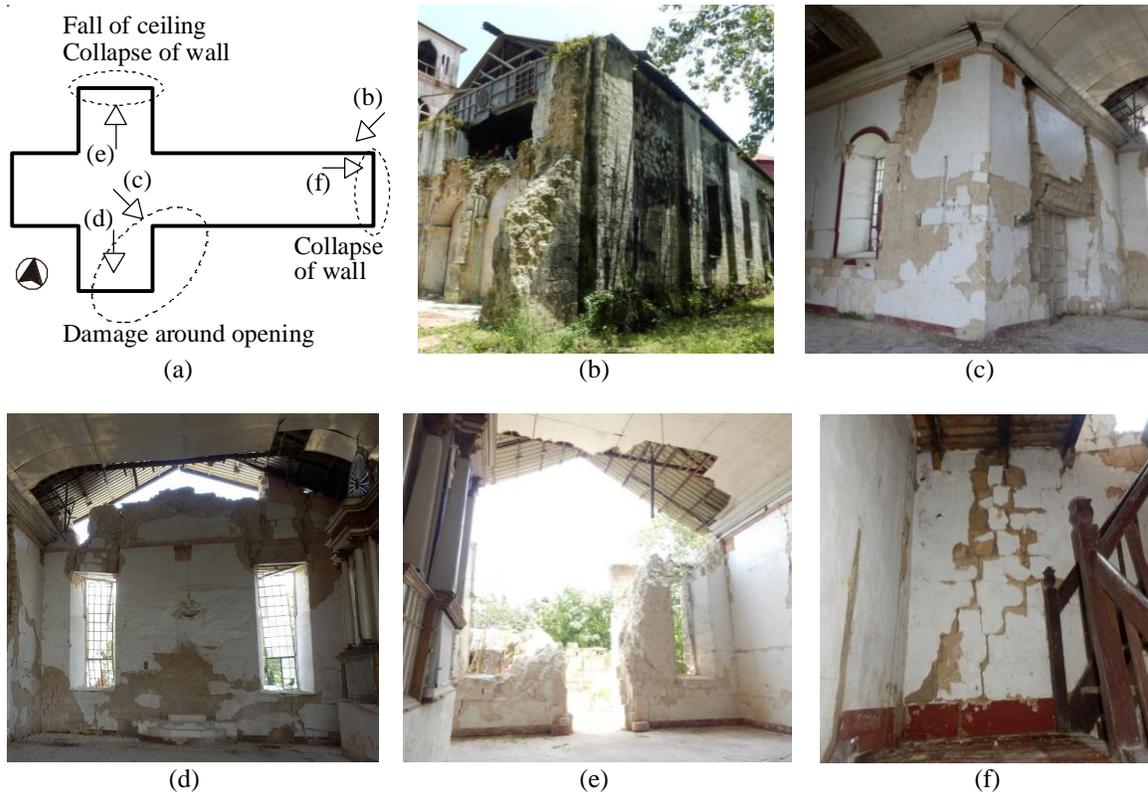
Figure 3. Damage due to Bohol earthquake; photographed on August 1, 2014.

Collapsed walls, peeling wall stone, corner deformation, and collapsed ceiling were the main damages observed. The points of main damage are illustrated by dashes line and arrow head in Figure 3 (a). Then, (b) to (f) say the photographing point of Figure 3 (b) to (f).

The eastern wall of the second floor collapsed, as shown in Figure 3 (b); significant damage was observed around the opening and top of the southern gable wall, as shown in Figure 3 (c) and (d). The northern gable wall collapsed completely, as shown in Figure 3 (e). The shear deformation of the eastern wall of the ground floor is shown in Figure 3 (f). Such types of damage were observed throughout the church.

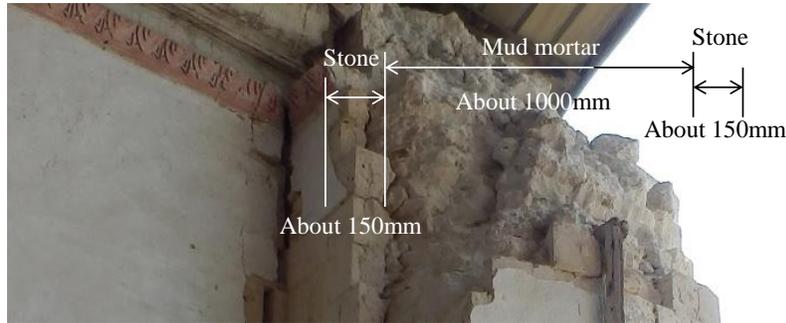
Figure 4. Construction of wall.

As the entire northern wall collapsed, the make-up and material thickness of the wall could be verified, as shown in Figure 4. Coral stones are arranged on both surfaces of the thick wall; the radius and thickness of each stone was approximately 300 mm and 150 mm, respectively. The space between the coral stones is filled up with mud mortar, which had a thickness of approximately 1000 mm.

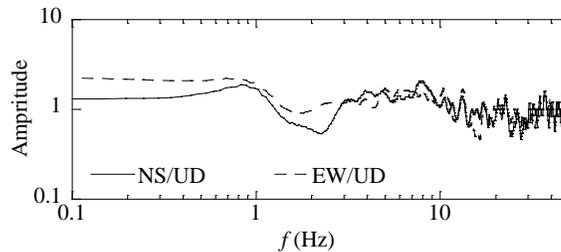
Figure 5. H/V spectrum on the ground point.

We conducted microtremor measurements of the ground to clarify surface conditions. The measurement was performed on the free ground at x point, as shown in Figure 2 (c). The frequency of the ground ranged between 7–9 Hz, as shown in Figure 5.

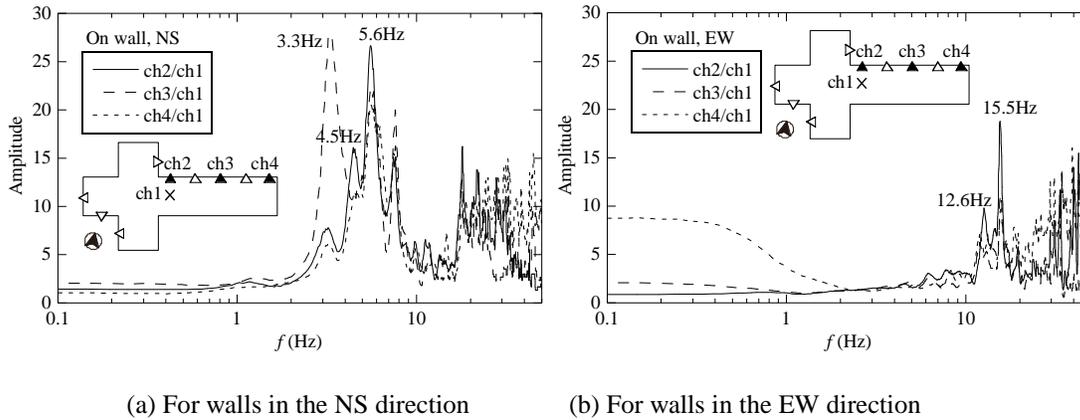
Figure 7. Fourier spectral ratio.

Fourier spectral ratios in the out-of-plane and in-plane directions, obtained using the three sensors installed in wall A, are illustrated in Figure 7. The peaks are clear in both directions; the 1<sup>st</sup>, 2<sup>nd</sup>, and 3<sup>rd</sup> natural frequencies in the out-of-plane direction are 3.3 Hz, 4.5 Hz, and 5.6 Hz, respectively. In addition, the 1<sup>st</sup> and 2<sup>nd</sup> natural frequencies in the in-plane direction are 12.6 Hz and 15.5 Hz, respectively. The 1<sup>st</sup> natural frequencies of walls A to E in both the directions are indicated in Table 1.

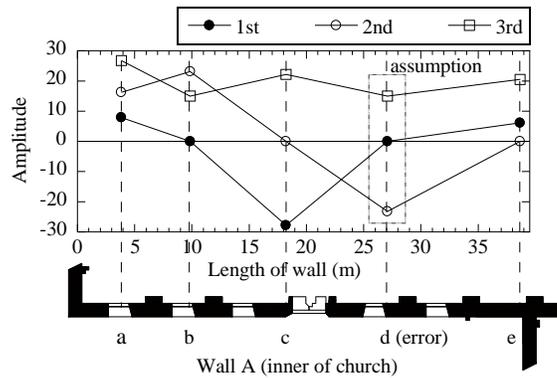
Figure 8. Vibration mode of Wall A.

The vibration mode of wall A is shown in Figure 8. The five sensors are named a to e, and the 1<sup>st</sup> to 3<sup>rd</sup> modes are illustrated. As measurement could not be performed using sensor d, the value of sensor b is used, based on a past study (Takiyama 2012).
