INVESTIGATION OF DAMAGE OCCURRED ON DERBENDIKHAN DAM DURING EARTHQUAKE EXCITATION THROUGH FINITE ELEMENT ANALYSIS

CAGRI MOLLAMAHMUTOGLU¹ and IDRIS BEDIRHANOGLU²

In this study, the performance of a damaged dam was evaluated through a three-dimensional finite element model. The dam is located in Derbendikhan city of Northern Iraq and damaged during a 7.3 magnitude earthquake which was happened 30 kilometers south of Halabja city. Derbendikhan dam which was built between the years 1956-1961 is a clay-core rock fill dam. The damage of the dam was investigated at the site right after the earthquake and some cracks were observed in the main body of the dam. The main goal of this work is to present the results of the survey which was conducted at the site and investigating the damage development mechanism through a realistic three-dimensional finite element model of the dam. As complying with the observations at the site, the finite element analysis has shown that the primary failure mechanism is due to the separation of the core and rock fill sections at the downstream side of the dam.

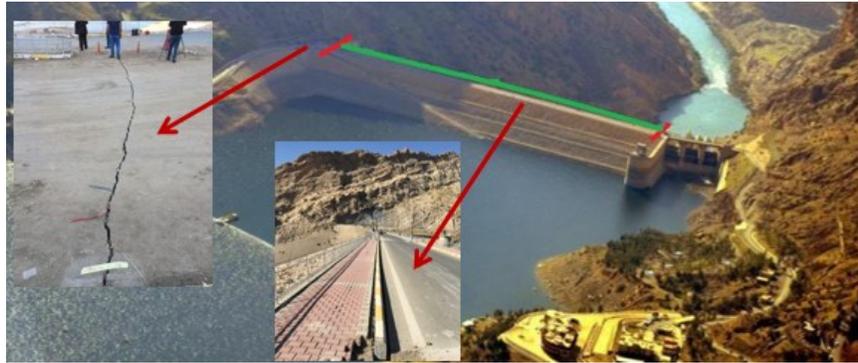
of the span of the dam. Crack indicates a suspected case of separation of the clay core and the surrounding rock-fill sections. In this study, a 3D finite element model with infinite boundary conditions and hydrodynamic effects is used to analyze the case. Mohr-Coulomb material model is used with characteristic values encountered in rock-fill clay core structures. Moreover, actual schematics of the structure are unavailable thus Google-Earth measurements and characteristic slope values with some information from a photo of the dam obtained from site investigation, will be used to model the geometry of the dam. Nevertheless, it will be shown that observed damage is likely a result of the partial separation of core and surrounding filling.

The earthquake focused in this study was occurred on 12.11.2007 at UTC 18:18:17 (21:18:17 local time) at 30 Km south of the city of Halabja, Suleymaniyah/Iraq on the Bitlis-Zagros rupture zone near Iraq-Iran border. The faults of the rupture zone caused an earthquake with a magnitude of 7.3 Mw. Due to the first announcement by USGS, the epicenter is located at 34.957°N 45.792°E with a depth of 25 km. Later the location is revised as farther to east 34.905°N 45.956°E and the depth is revised as 19 km. Thus the territorial address of the epicenter was shifted from Suleymaniyah/Iraq to Kermanshah/Iran. The earthquake was felt in a vast region and caused major damage to the dam structure. A prominent crack running through the span of the dam is visible on the crest of the dam as can be seen in Figure 2. This crack is on the downstream side and reaches up to 30 cm in the middle. Moreover, end cracks appeared on both sides of the dam. These findings suggest rocking of the entire dam body along the stream direction and resulting separation of the core and filling sections. Also, depression occurred on the downstream side of the crest.

Figure 2. Lateral downstream crack (green) and end cracks (red) occurred on Derbendikhan dam structure during the earthquake.

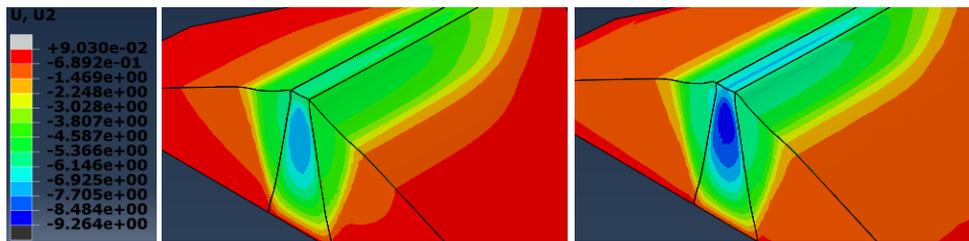
Analysis results are reasonable with the field observations (Figure 2). Figure 7 shows the vertical displacement field before (left) and after (right) the earthquake. It is seen that due to self-weight consolidation type settling occurs and as observed in the field an additional depression around 1 m occurs around the crest region after the earthquake.

Figure 7. Vertical displacement (m) field before (left) and after the (right) earthquake.

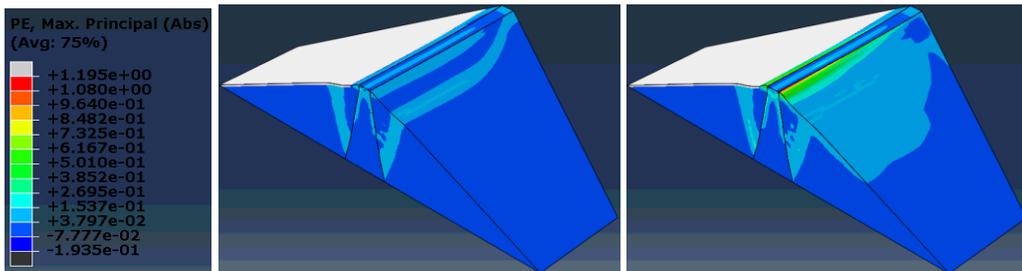
Figure 8. Absolute values of max principal plastic strains before (left) and after (right) earthquake.

In the plastic analysis, a measure of the concentration of max plastic strains can be assumed as probable fault (crack) zones. Figure 8 shows the absolute value of max plastic strains which also indicates the end slip bands which manifested as end cracks and the lateral downstream crack running along the length. Mohr-Coulomb material model seems to be reasonable when elaborate data on material parameters are not available. As it is seen that this simple nonlinear material model with assumed parameters and partly assumed dimensions are able to capture the observed damage mechanism. Thus we can conclude a possible separation of the core and rock fill sections which is prominent at the downstream side. The water pressure seems to limit the separation on the upstream side. Overall the damage mechanism fits with the on-site outer observations. Thus it can be concluded that the dam structure is non-negligibly damaged and care must be taken.
