Geological Factors Contributing to Landslide Incident in Malaysia - Case Study Batang Kali Landslide Disaster, Hulu Selangor, Selangor.

Keywords: Batang Kali Landslide, Disaster Risk Reduction, Forensic Geology

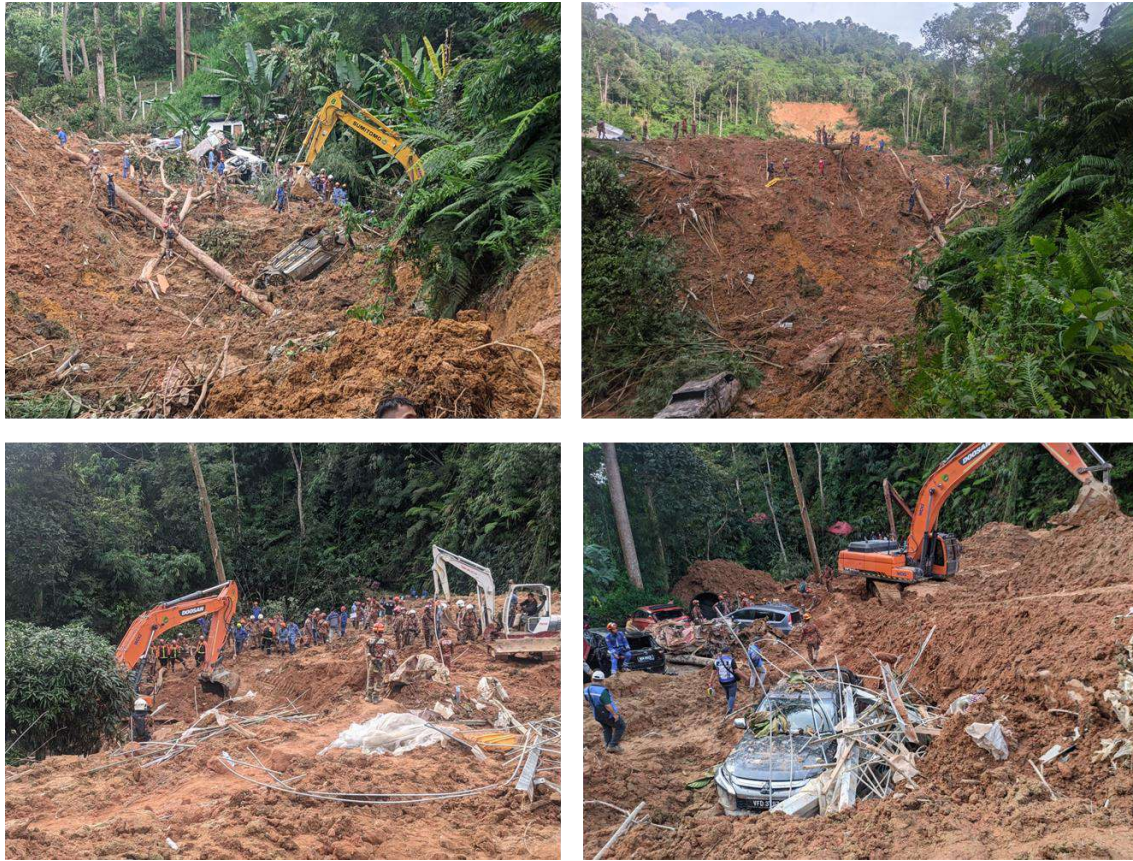
Fig. 1: Photo during Search and Rescue (SAR) Operation at the campsite and agriculture area

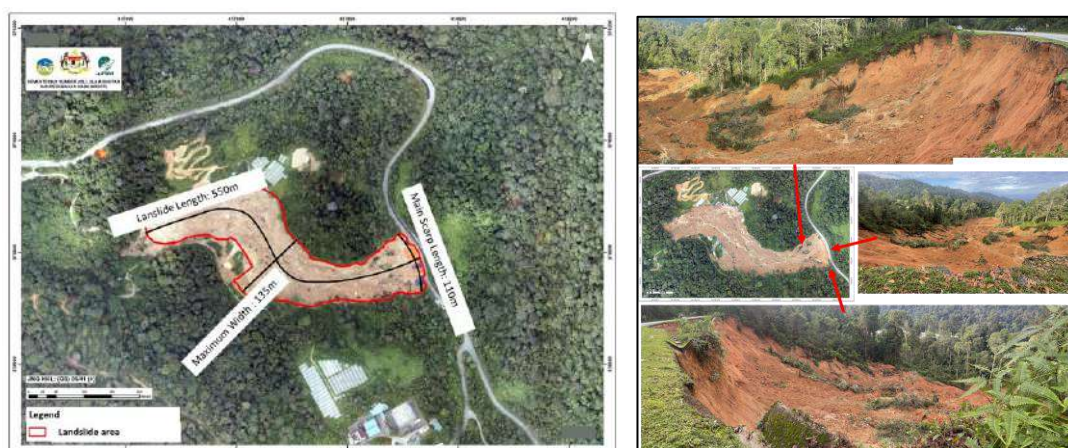
The landslide occurred on a man-made slope that was originally constructed to provide a platform for the Batang Kali-Genting Highlands Road. The cut slope at the top of the road platform is still intact, while the fill slope at the bottom has failed. The height of the fill slope from the road platform to the foot of the slope is approximately 50m and the gradient of the slope is approximately 25° - 30° . The width

of the main scarp is 110m, the depth is 14m and the length of the path and accumulation area is approximately 550m (Fig. 3). The total volume of the landslide debris is approximately 282,170 m³ which includes the initiation zone and the accumulation zone. In addition, the landslide also transported soil materials, boulders, and trees along the route and deposited at the lower and sloping part of the valley downstream. According to Varnes (1978), landslides are classified as complexes that combine a rotational slide with earth flow.

Fig. 3: Dimension of the landslide and the photo of the main landslide body.

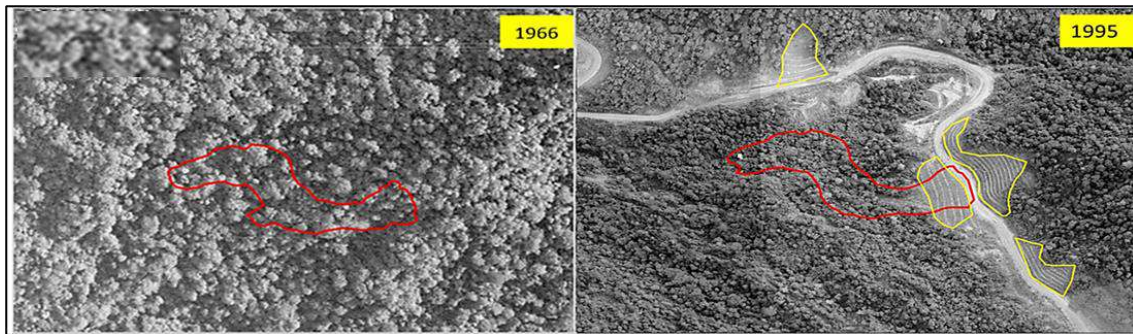
Analysis of the 1966 aerial photo imagery shows that the investigation area was covered by forest and there was no disturbance on the natural terrain. The 1995 aerial photo image also indicates the condition after the road was ready to be built where there were activities of cutting and filling the slope. Slope profiling also has been carried out on the upper slope and lower slope of the road platform around the landslide area (Fig.4). Besides that, analysis of satellite images from Google Earth starting from 2002 to 2021 shows that several land use changes have taken place within the investigation area. Land use patterns changed significantly from February 2015 when land clearing activities, construction of greenhouses for agricultural activities, and construction of permanent structures took place (Fig. 5). The qualitative interpretation was based on the elements of location, size, shape, hue, texture, and pattern of the objects in the images used. Signs of slope instability and landslides are not clearly visible in the vicinity but rather there is a sign of erosion at a modest to high grade in areas that were explored before vegetable planting and rain protection structures were built. On the other hand, analysis of Interferometric Synthetic Aperture Radar (InSAR) data revealed some changes in the earth's terrain prior to the failure in the investigation area. The method of monitoring using InSAR satellites is seen to be an effective monitoring tool for landslide risk. The analysis was divided into 5 monitoring zones to assess any landform changes (Fig. 6). Zone A covering the foot of the slope has shown a downward movement trend with a rate of 21.25 mm/year starting on 3 December 2022 until 15 December 2022 which was the day before the landslide occurred. Likewise, Zone C which includes the upper slope and lower slope has also indicated a downward movement with a rate of 21.48 mm/year starting on 24 July

Fig. 4: Arial photo of the landslide area in 1966 and 1995 which red polygon indicates landslide area. (Source: Department of Survey & Mapping Malaysia)

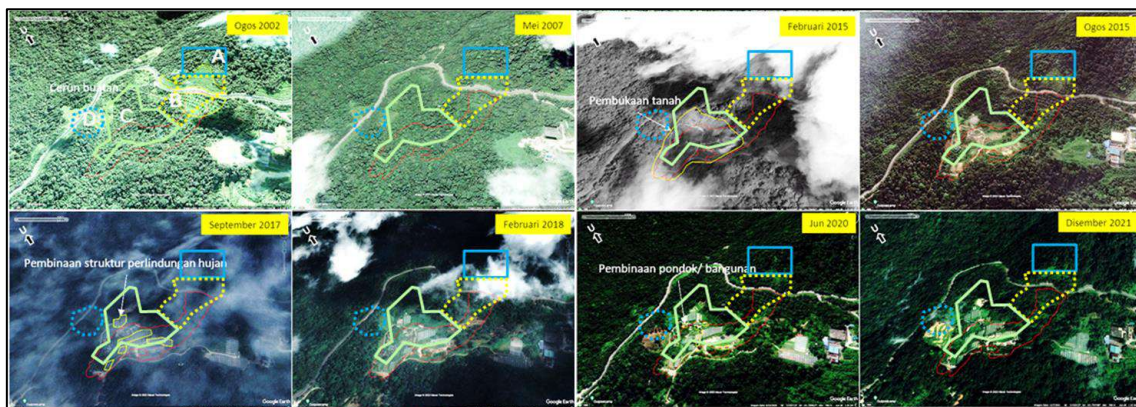
Fig. 5: Land use change from 2002 to 2021 based on satellite imagery. (Source: Google Earth)

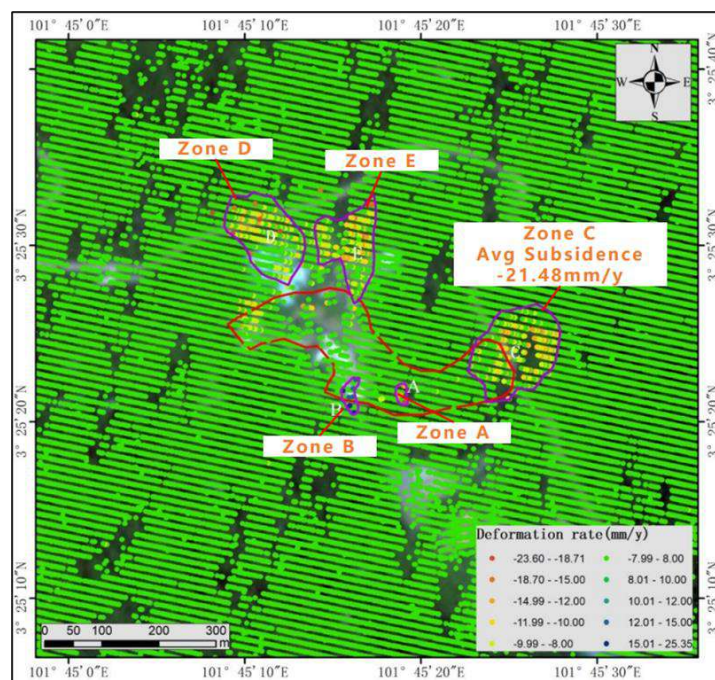
Fig. 6: Movement analysis using InSAR satellite data within the investigation area (Source: Spacegen Sdn Bhd).

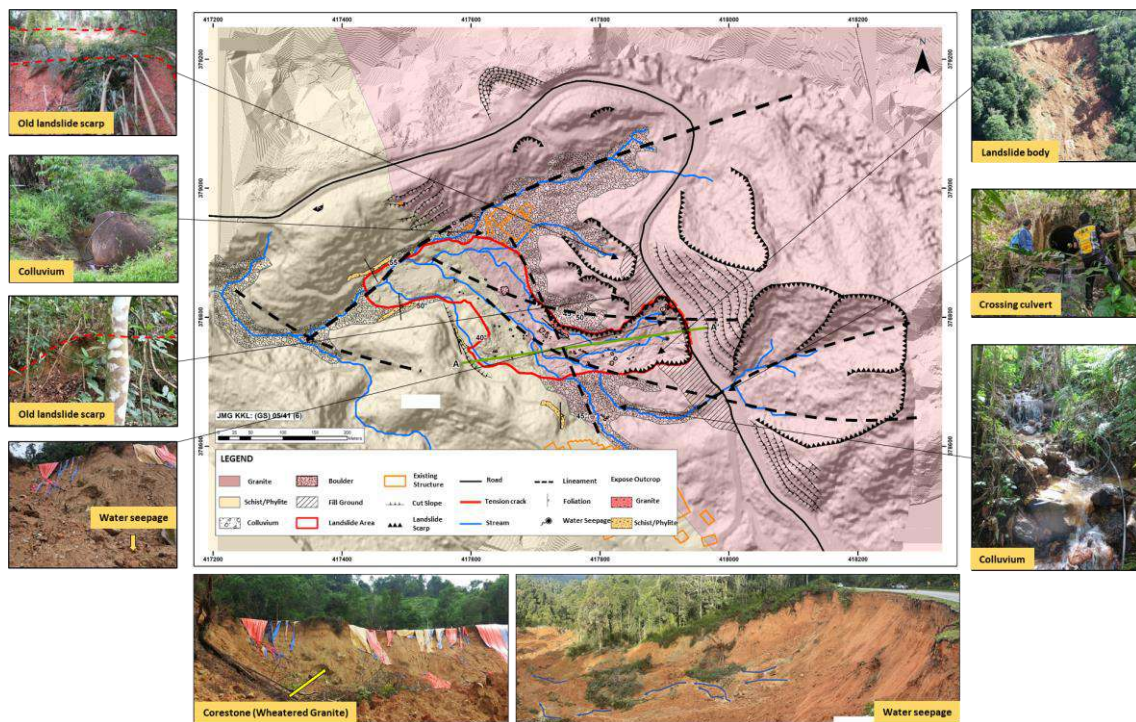
Fig. 7: Geomorphological Map of the landslide (Department of Mineral and Geoscience Malaysia, 2023)

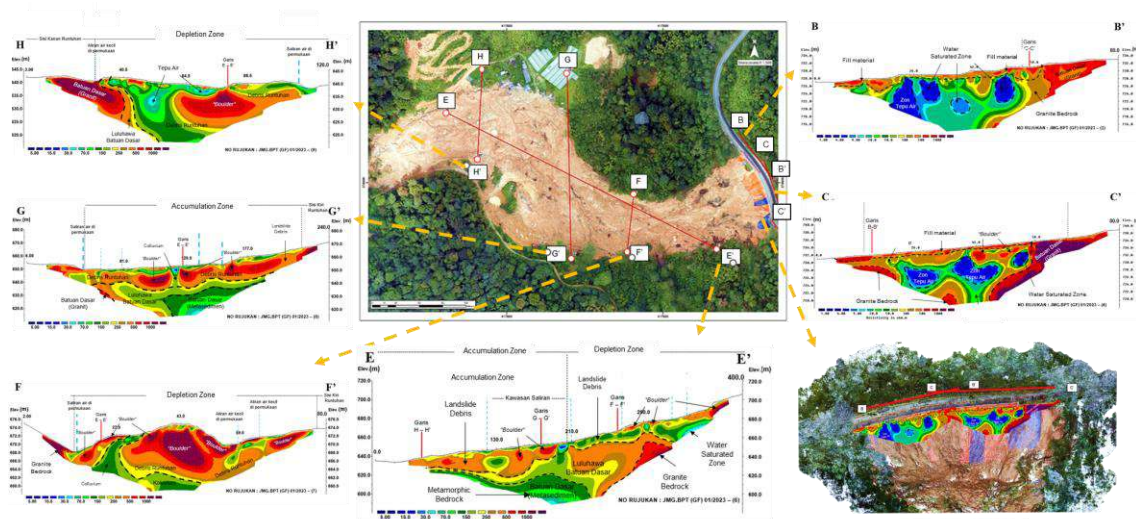
A geophysical survey application in landslide investigation aims to understand the subsurface characterization, groundwater regime, and localization of the shear plane (Hussain et al., 2022). The 2-dimensional electrical resistivity method was used in the investigation with a total of 8 survey lines within the landslide body (Fig. 8). The result shows that the water-saturated zone was found in the main landslide scarp area where the resistivity values range from 1 Ω m

to 9 Ω m. This zone consists of materials that have high porosity and permeable properties that allow water and electric current to flow easily. Whereas within the landslide area, water saturated zone in the landslide debris was interpreted at the low resistivity value zone range from 5 Ω m to 50 Ω m. Medium resistivity value zones (31 Ω m - 500 Ω m) are interpreted as the material within the landslide debris that can be found from the surface down to a depth of 20m followed by a layer beneath

the collapse debris layer that is interpreted as weathered rock and colluvium. The third layer at the bottom is interpreted as bedrock. The lower magnitude values indicate the different lithological nature of the bedrock and are interpreted as metamorphic rocks. The high intensity zones (500 Ω m - 5000 Ω m) within the landslide debris layer are interpreted as "boulders" and granite-type bedrock based on information from the geology of the area.

Fig. 8: Geophysical result of the landslide area

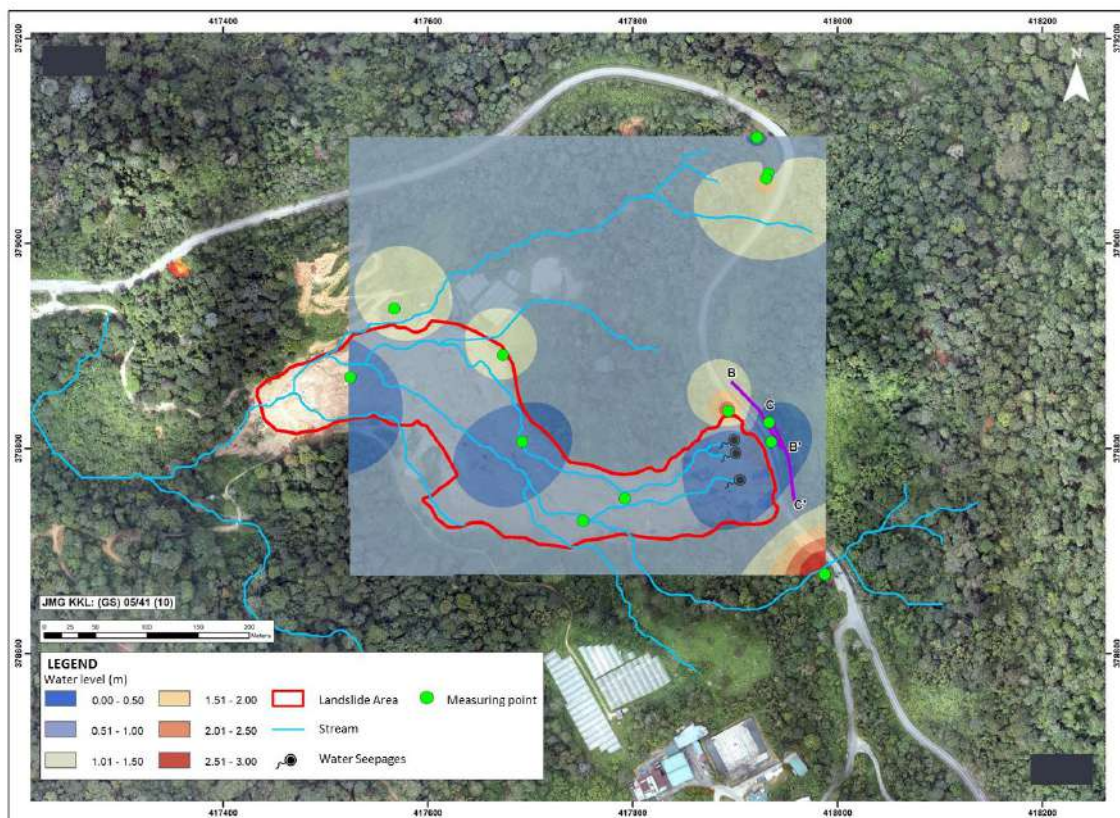
Besides that, hand auger holes and Mackintosh probes testing locations were utilized in measuring the groundwater levels a week after the incident. Based on the analysis of the water level measurements in the field, an isopach map of the groundwater level from the ground surface was generated

(Fig.9). Generally, the direction of underground water flow in this area is consistent with the hydraulic head contour which flows from the east to the west of the site. The high water table was found in the main landslide scarp area in line with the results from the geophysical study using the 2D electrical resistivity survey method which indicates the water-saturated zone.

Fig. 9: The isopach map of groundwater level from the ground surface in the landslide area

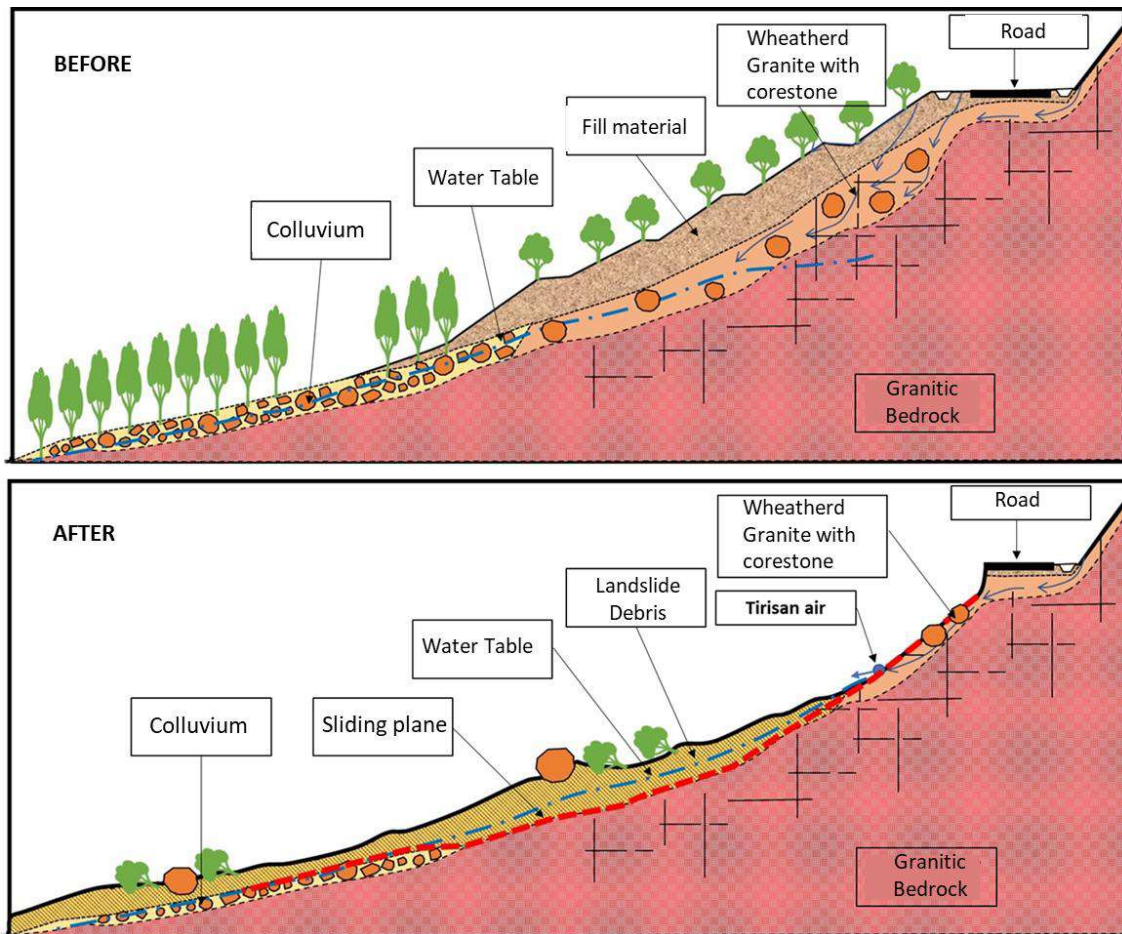
Generally, geology, geomorphology, climate, and anthropogenic activities, are factors controlling the stability of a slope (Komadja et al., 2020). The Batang Kali landslide is known to have been caused by geological elements within the slope and the presence of underground water. The road platform has been built on top of a cut slope while the fill slope has been constructed on top of weathered granite containing a rock boulder named corestone and colluvium layer at the foot of the slope which is characterized as a geological sensitive deposit due to loose and uncompacted materials. The presence of groundwater flow in the slope has formed a water-saturated zone at the foot of the slope which results in the soil matrix becoming loose and contributes to the instability of the entire slope. Apart from that, anthropogenic factors and land-use activities in the vicinity also significantly contributed to the instability of the slope thus increasing the risk of landslide.

Figure 10 depicts the schematic diagram of the landslides.

Fig. 10: Schematic geological cross-section of the landslides.

investigation and analysis as well. Thus, the findings of the investigation should also be used in designing the slope repair work and mitigating measures in the area. Additionally, it is crucial to assess the stability of existing slopes in the vicinity of the landslide area for proper mitigation measures as well as a routine slope maintenance of the man-made slope should cover the entire slope area.
