Geological Factors Contributing to Landslide Incident in Malaysia - Case Study Batang Kali Landslide Disaster, Hulu Selangor, Selangor.

Keywords: Batang Kali Landslide, Disaster Risk Reduction, Forensic Geology

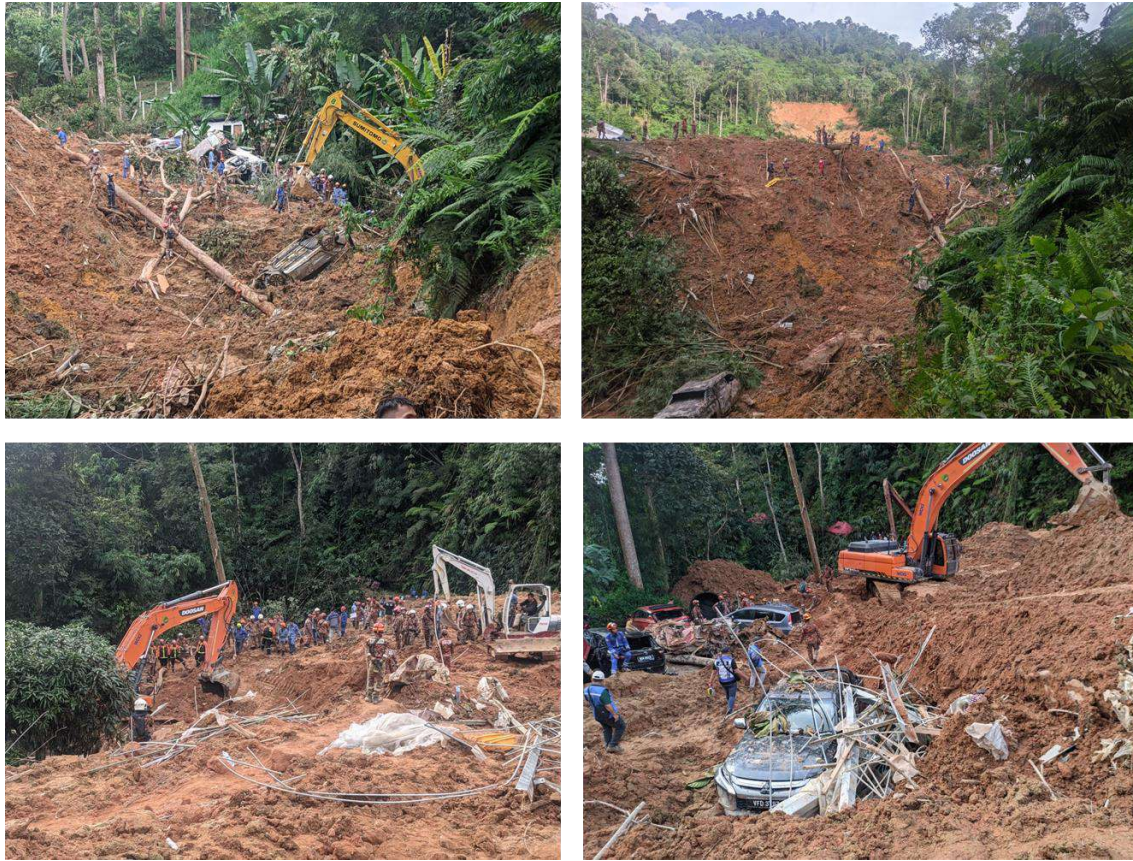
Fig. 1: Photo during Search and Rescue (SAR) Operation at the campsite and agriculture area

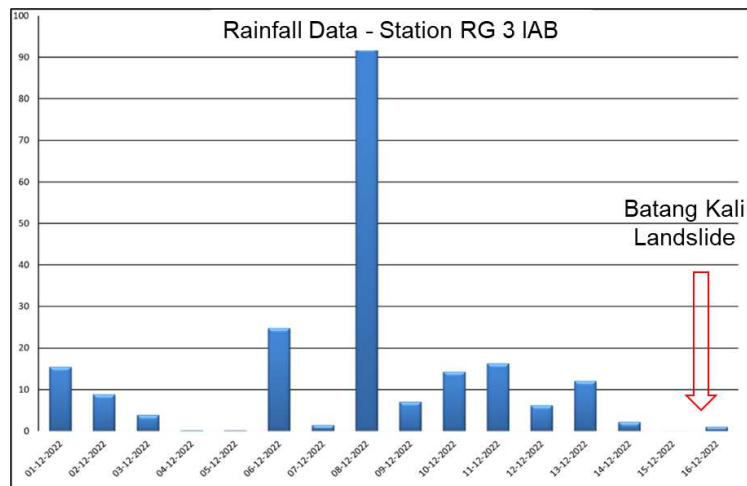
data for the period of 1 December to 30 December 2022 shows the heavy rainfall outflow of the Northeast Monsoon occurred in early December 2022 with the highest rate at 92.2mm a day. The cumulative rainfall record 15 days before the incident for the nearest Station (RG 3 IAB) was also at a level of 205.6mm. However, there was no rainfall recorded during the day of the incident.

Fig. 2: The cumulative amount of rain 15 days before the event for the closest station RG 3 IAB was 205.6mm with the highest amount of daily rainfall being 92.2mm.

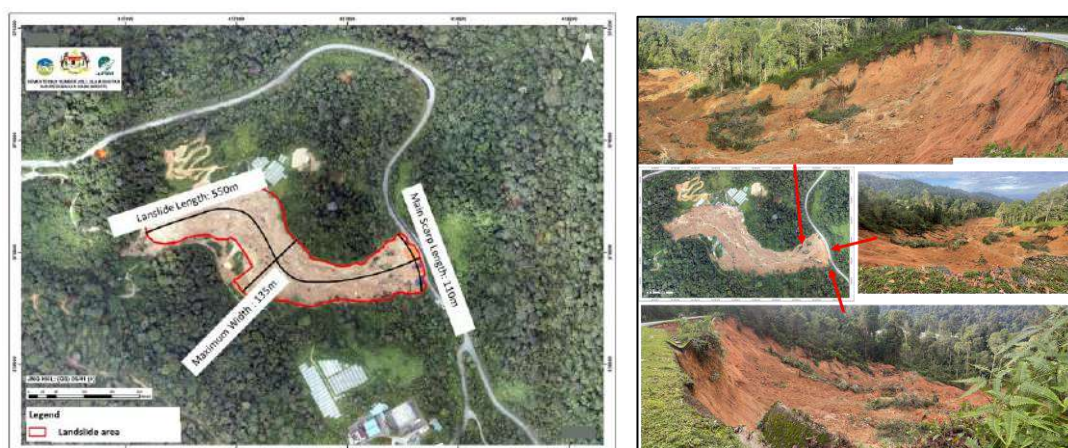
The landslide occurred on a man-made slope that was originally constructed to provide a platform for the Batang Kali-Genting Highlands Road. The cut slope at the top of the road platform is still intact, while the fill slope at the bottom has failed. The height of the fill slope from the road platform to the foot of the slope is approximately 50m and the gradient of the slope is approximately 25° - 30° . The width

of the main scarp is 110m, the depth is 14m and the length of the path and accumulation area is approximately 550m (Fig. 3). The total volume of the landslide debris is approximately 282,170 m³ which includes the initiation zone and the accumulation zone. In addition, the landslide also transported soil materials, boulders, and trees along the route and deposited at the lower and sloping part of the valley downstream. According to Varnes (1978), landslides are classified as complexes that combine a rotational slide with earth flow.

Fig. 3: Dimension of the landslide and the photo of the main landslide body.

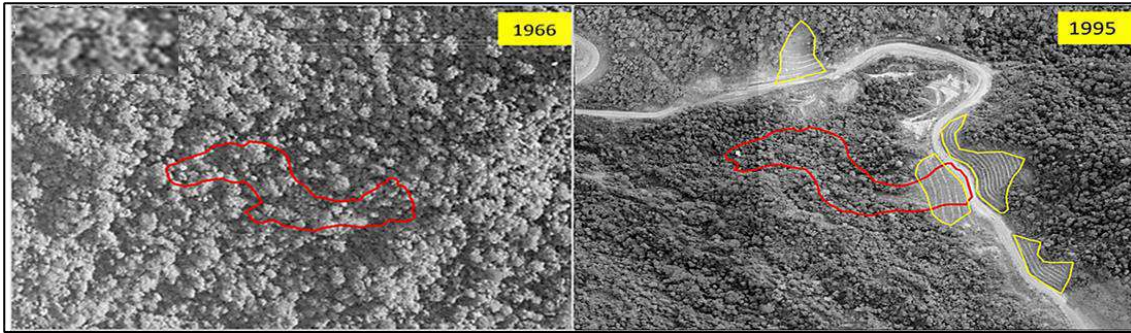
Analysis of the 1966 aerial photo imagery shows that the investigation area was covered by forest and there was no disturbance on the natural terrain. The 1995 aerial photo image also indicates the condition after the road was ready to be built where there were activities of cutting and filling the slope. Slope profiling also has been carried out on the upper slope and lower slope of the road platform around the landslide area (Fig.4). Besides that, analysis of satellite images from Google Earth starting from 2002 to 2021 shows that several land use changes have taken place within the investigation area. Land use patterns changed significantly from February 2015 when land clearing activities, construction of greenhouses for agricultural activities, and construction of permanent structures took place (Fig. 5). The qualitative interpretation was based on the elements of location, size, shape, hue, texture, and pattern of the objects in the images used. Signs of slope instability and landslides are not clearly visible in the vicinity but rather there is a sign of erosion at a modest to high grade in areas that were explored before vegetable planting and rain protection structures were built. On the other hand, analysis of Interferometric Synthetic Aperture Radar (InSAR) data revealed some changes in the earth's terrain prior to the failure in the investigation area. The method of monitoring using InSAR satellites is seen to be an effective monitoring tool for landslide risk. The analysis was divided into 5 monitoring zones to assess any landform changes (Fig. 6). Zone A covering the foot of the slope has shown a downward movement trend with a rate of 21.25 mm/year starting on 3 December 2022 until 15 December 2022 which was the day before the landslide occurred. Likewise, Zone C which includes the upper slope and lower slope has also indicated a downward movement with a rate of 21.48 mm/year starting on 24 July

Fig. 4: Arial photo of the landslide area in 1966 and 1995 which red polygon indicates landslide area. (Source: Department of Survey & Mapping Malaysia)

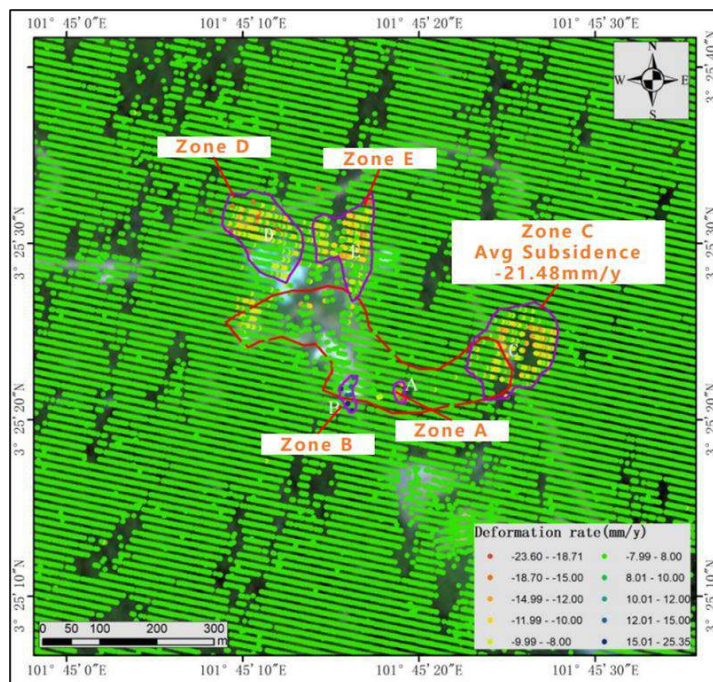
Fig. 6: Movement analysis using InSAR satellite data within the investigation area (Source: Spacegen Sdn Bhd).

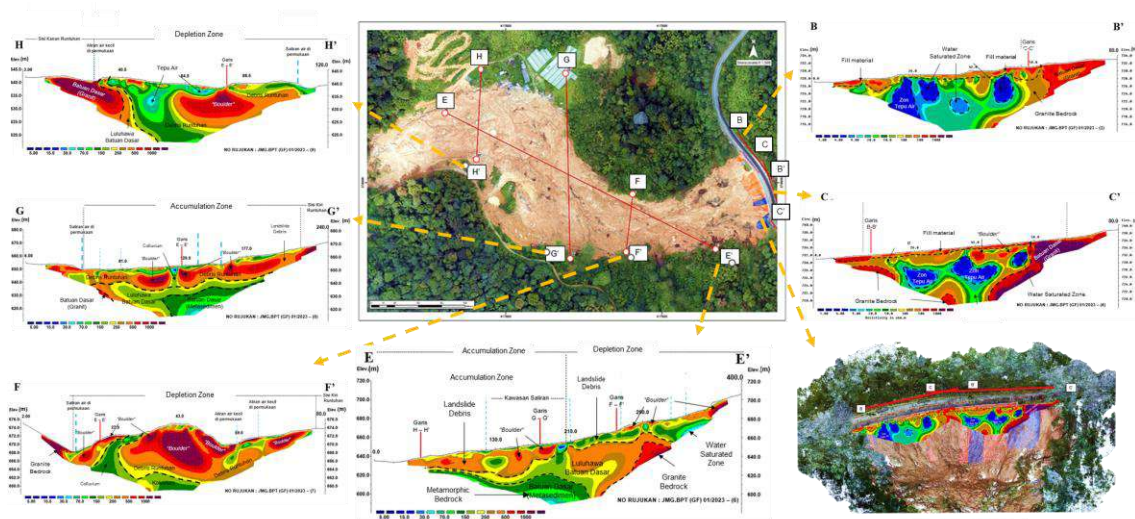
to 9 Ω m. This zone consists of materials that have high porosity and permeable properties that allow water and electric current to flow easily. Whereas within the landslide area, water saturated zone in the landslide debris was interpreted at the low resistivity value zone range from 5 Ω m to 50 Ω m. Medium resistivity value zones (31 Ω m - 500 Ω m) are interpreted as the material within the landslide debris that can be found from the surface down to a depth of 20m followed by a layer beneath

the collapse debris layer that is interpreted as weathered rock and colluvium. The third layer at the bottom is interpreted as bedrock. The lower magnitude values indicate the different lithological nature of the bedrock and are interpreted as metamorphic rocks. The high intensity zones (500 Ω m - 5000 Ω m) within the landslide debris layer are interpreted as "boulders" and granite-type bedrock based on information from the geology of the area.

Fig. 8: Geophysical result of the landslide area

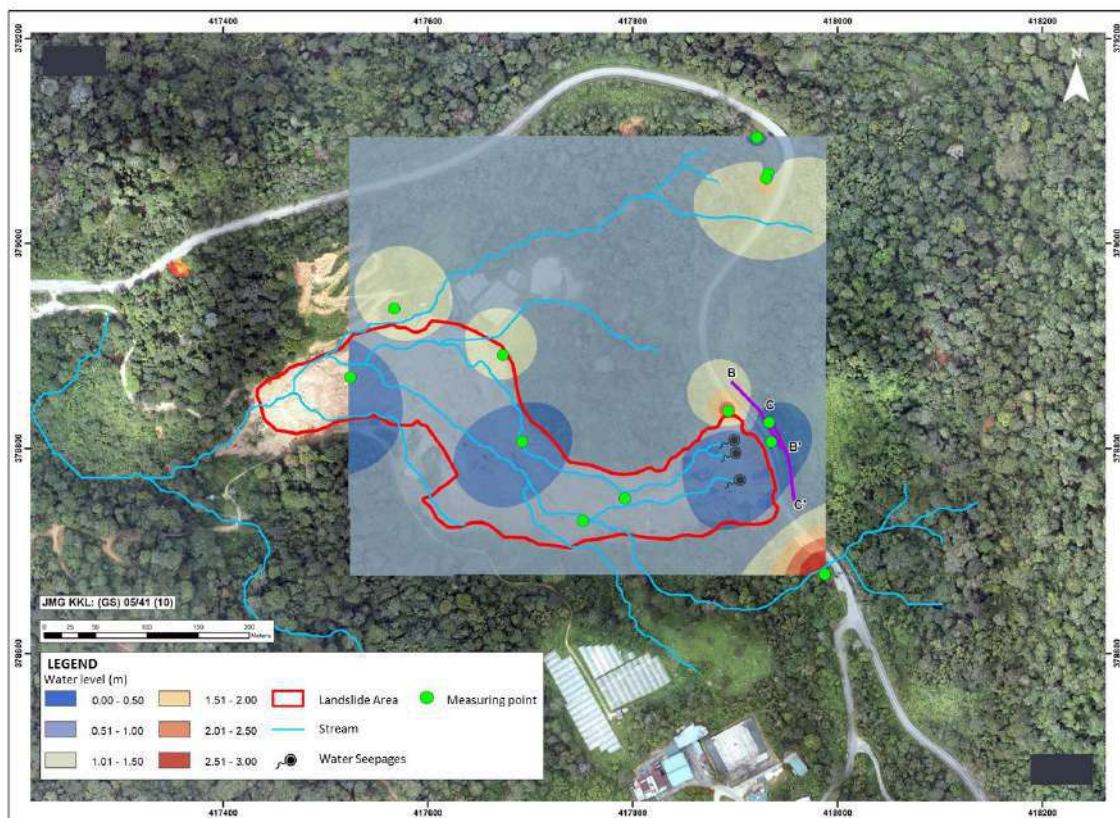
Besides that, hand auger holes and Mackintosh probes testing locations were utilized in measuring the groundwater levels a week after the incident. Based on the analysis of the water level measurements in the field, an isopach map of the groundwater level from the ground surface was generated

(Fig.9). Generally, the direction of underground water flow in this area is consistent with the hydraulic head contour which flows from the east to the west of the site. The high water table was found in the main landslide scarp area in line with the results from the geophysical study using the 2D electrical resistivity survey method which indicates the water-saturated zone.

Fig. 9: The isopach map of groundwater level from the ground surface in the landslide area

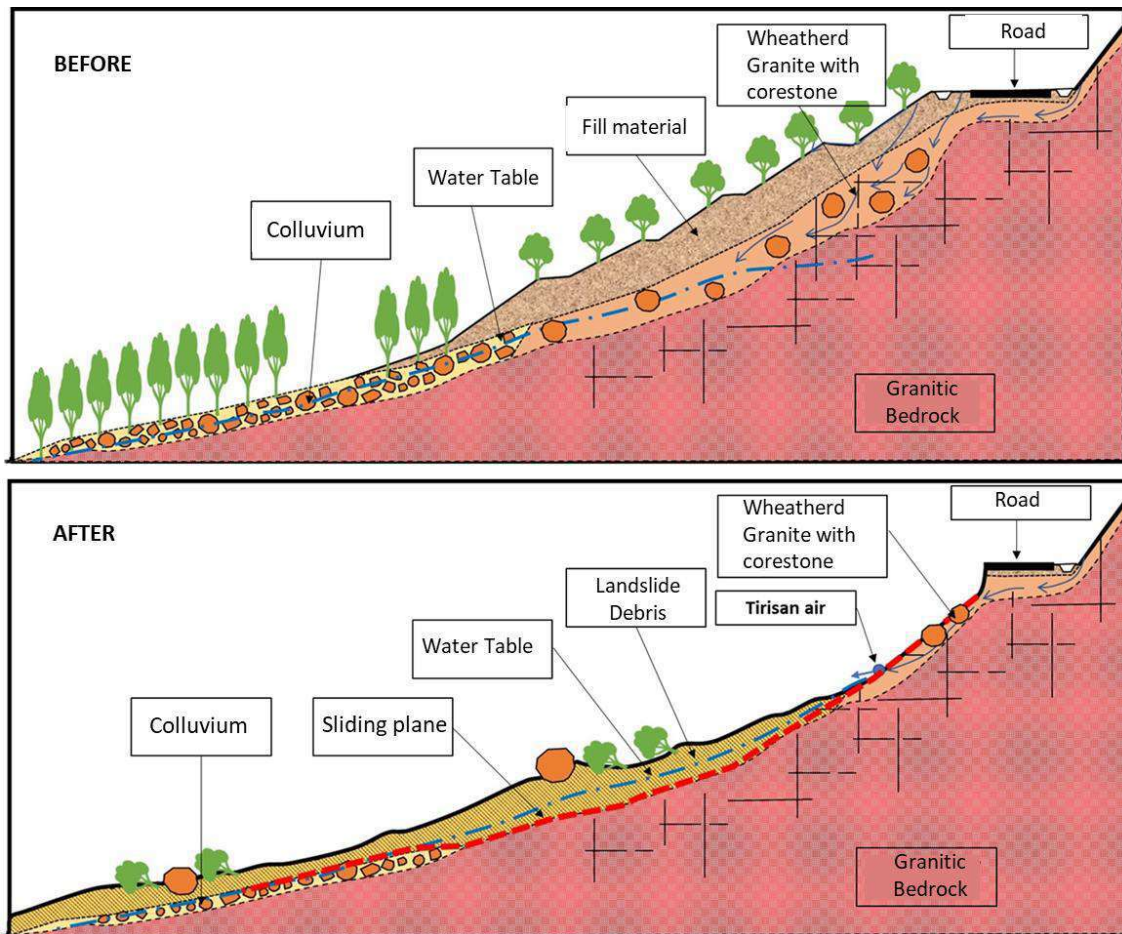
Generally, geology, geomorphology, climate, and anthropogenic activities, are factors controlling the stability of a slope (Komadja et al., 2020). The Batang Kali landslide is known to have been caused by geological elements within the slope and the presence of underground water. The road platform has been built on top of a cut slope while the fill slope has been constructed on top of weathered granite containing a rock boulder named corestone and colluvium layer at the foot of the slope which is characterized as a geological sensitive deposit due to loose and uncompacted materials. The presence of groundwater flow in the slope has formed a water-saturated zone at the foot of the slope which results in the soil matrix becoming loose and contributes to the instability of the entire slope. Apart from that, anthropogenic factors and land-use activities in the vicinity also significantly contributed to the instability of the slope thus increasing the risk of landslide.

Fig. 10: Schematic geological cross-section of the landslides.

investigation and analysis as well. Thus, the findings of the investigation should also be used in designing the slope repair work and mitigating measures in the area. Additionally, it is crucial to assess the stability of existing slopes in the vicinity of the landslide area for proper mitigation measures as well as a routine slope maintenance of the man-made slope should cover the entire slope area.
