SEISMIC COLLAPSING ANALYSIS OF ONE-STORY WOODEN KINDERGARTEN STRUCTURE AGAINST STRONG EARTHQUAKE GROUND MOTION

3-D collapsing process analysis of an old Japanese-style one-story wooden structure under two strong earthquake ground motions with a seismic intensity level was carried out in order to investigate the seismic performance of this one-story wooden structure without/with seismic retrofit. As a result, this wooden structure collapsed against a strong earthquake ground motion with the JMA seismic intensity “6 upper” level.

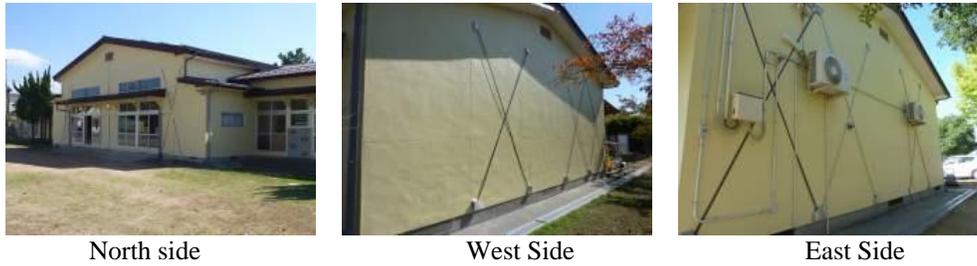
Photo 1. View of one-story kindergarten wooden structure retrofitted with “BRACE-X”.

Table 1 shows the seismic performance ratio of this one-story kindergarten wooden structure, and the seismic performance ratios of both X and Y directions are 0.28 and 0.21, respectively. Photo1 shows views of one-story kindergarten wooden structure ret-

rofitted with “BRACE-X” using the Carbon Fiber Reinforced Plastic material. Figure 1 indicates seismic retrofit elevation plan of this wooden structure using “BRACE-X” whose details are not presented in this paper due to the limited space.

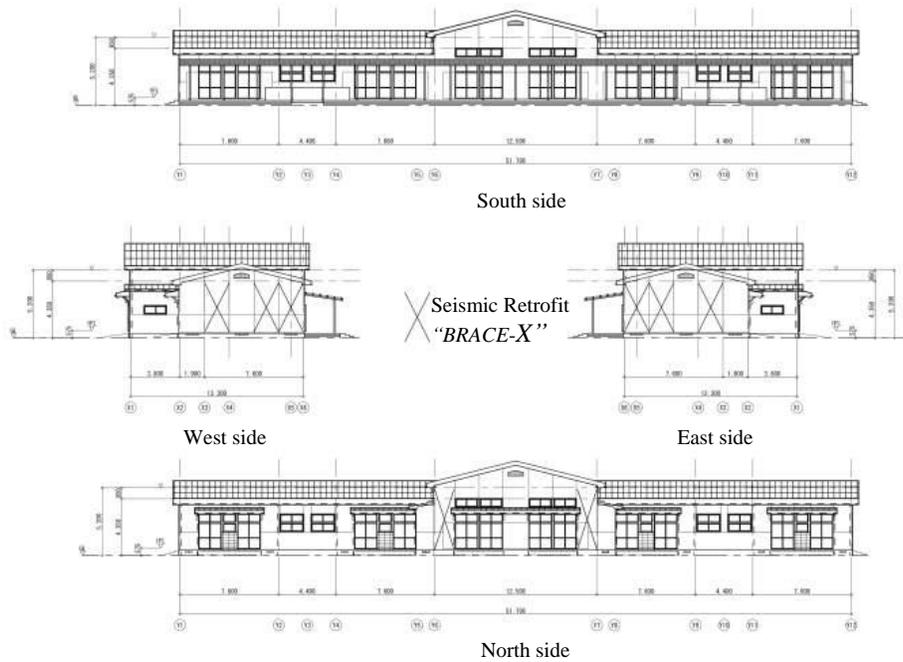
Figure 1. Seismic retrofit elevation plan of one-story kindergarten wooden structure (unit : mm).

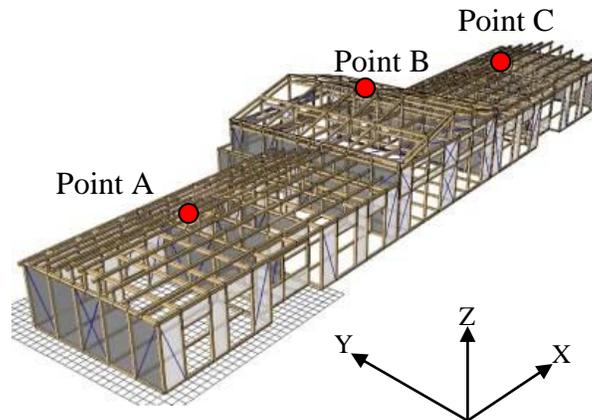
Figure 2. Seismic collapsing model of one-story kindergarten wooden structure.

Figure 2 shows a seismic collapsing frame model of one-story kindergarten wooden structure, which has walls and braces in the complete frame model with roof rafters.

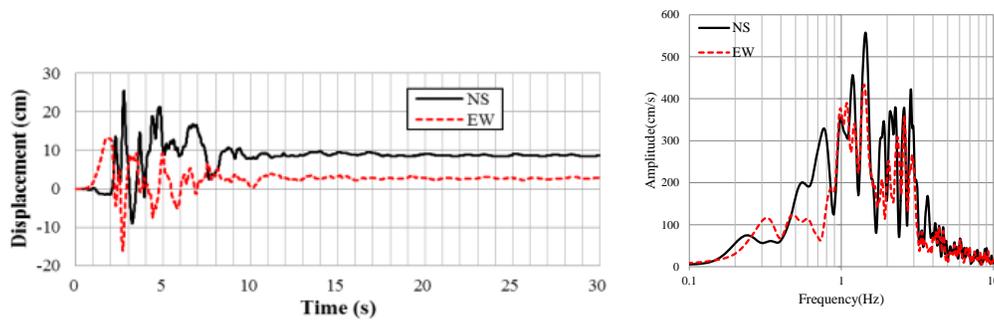
Figure 3. Displacement waves and Fourier acceleration spectra of JMA Kobe wave.

earthquake motion spectrum on the difference of seismic response can be investigated by using two earthquake wave records whose same level intensity has a different peak frequency in Fourier acceleration spectra. Figures 3 and 4 indicate two displacement wave data and their Fourier acceleration spectra for both NS and EW components in

each earthquake ground motion record shown in Table 2. In the JMA Kobe wave record shown in Figure 3, a peak frequency in each wave component is from 1Hz to 1.5Hz, and also a peak in each wave component of JR Takatori wave record illustrated in Figure 4 exists about 0.8Hz.

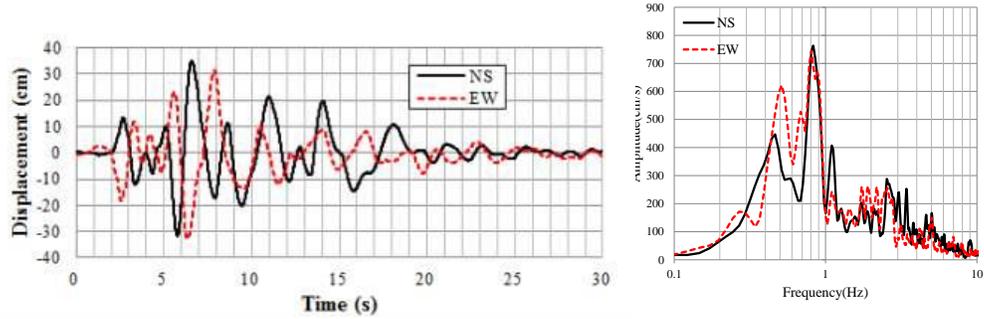
Figure 4. Displacement waves and Fourier acceleration spectra of JR Takatori wave.

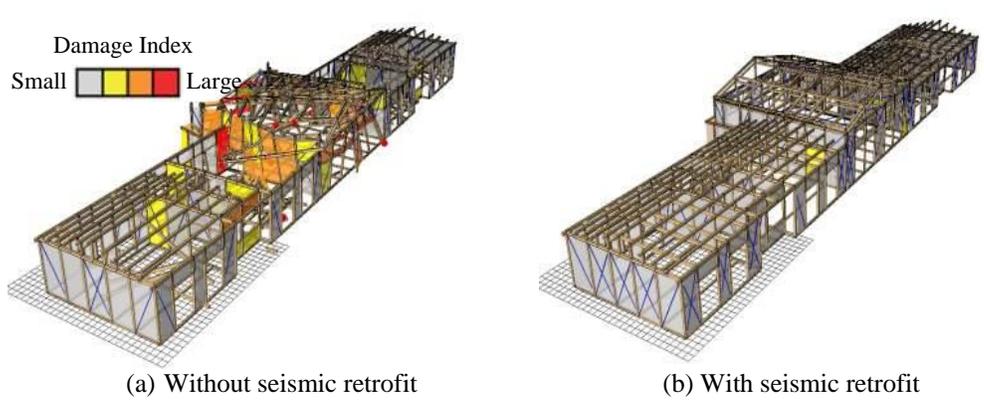
Figure 5. Seismic collapsing behavior against a strong earthquake ground motion (JMA-Kobe).

Figure 5 shows seismic collapsing results of one-story kindergarten wooden structure without/with seismic retrofit after JMA Kobe wave. The centre part of this one-story wooden structure without seismic retrofit collapses after JMA Kobe wave. On the other hand, there is little earthquake damage in the wooden structure after JMA Kobe wave

shown in Figure 5(b) because of seismic retrofit.

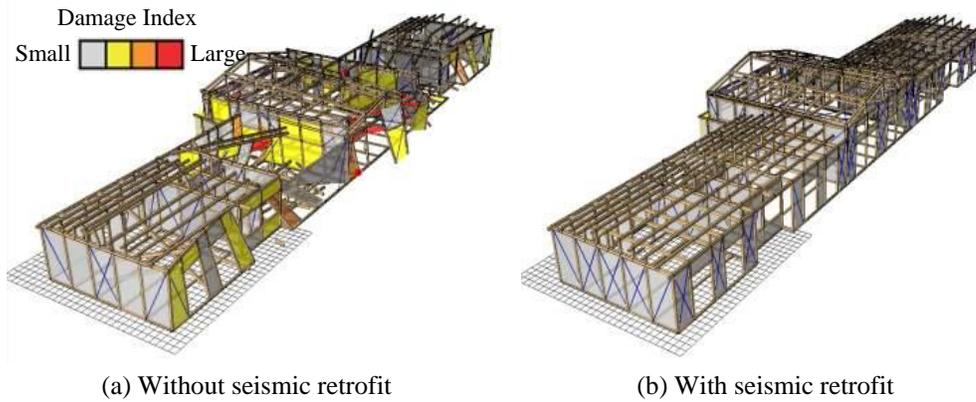
Figure 6. Seismic collapsing behaviour against a strong earthquake ground motion (JR-Takatori).

Figure 6 indicates seismic collapsing results of one-story kindergarten wooden structure without/with seismic retrofit after JR Takatori wave. It is found from this figure that the seismic damage of one-story wooden structure against JR Takatori is much larger than that against JMA Kobe. This is because JR Takatori wave record seems to have a peak frequency to cause severe damage of one-story wooden structure in comparison with JMA Kobe.

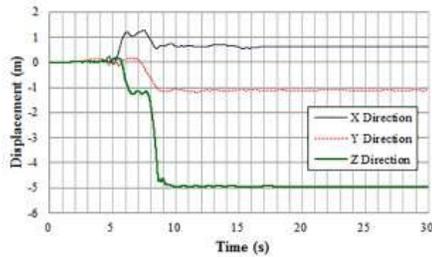
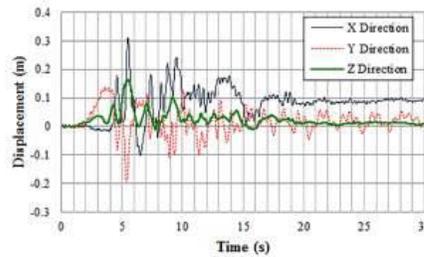
(a) Without seismic retrofit.

(b) With seismic retrofit.

Figure 7. Seismic response behaviour at Point A during a strong earthquake ground motion.

Figures 7, 8 and 9 show the displacement response behaviors at Points A, B and C in the one-story kindergarten wooden structure without/with seismic retrofit for during JMA Kobe wave, respectively. Seismic response behaviors of Z direction at Points A and C in the wooden structure without seismic retrofit shown in Figures 7 and 9 are almost 5m after 10 seconds because of the collapse of these parts of this wooden structure. On the other hand, there is a large displacement over 30cm in each displacement of Y direction in the seismic response behaviors at three points in the one-story wooden structure with seismic retrofit, and the collapse does not occur because of seismic retrofit. This implies that the seismic retrofit may have an effective seismic effect to avoid the damage of one-story wooden structure against a strong earthquake ground motion. Consequently, it is found that 3-D seismic collapsing analysis can numerically simulate the seismic response behaviour of an old one-story wooden structure without/with seismic retrofit during a strong earthquake ground motion.

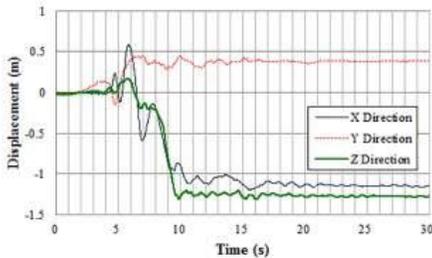
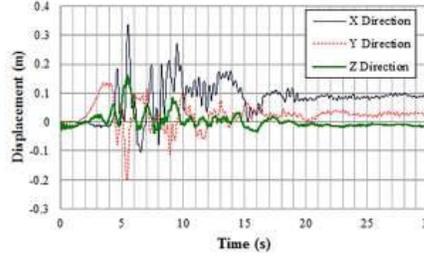
(a) Without seismic retrofit.

(b) With seismic retrofit.

Figure 8. Seismic response behaviour at Point B during a strong earthquake ground motion.

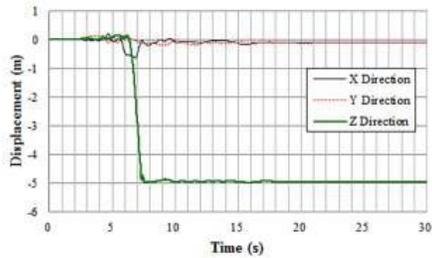
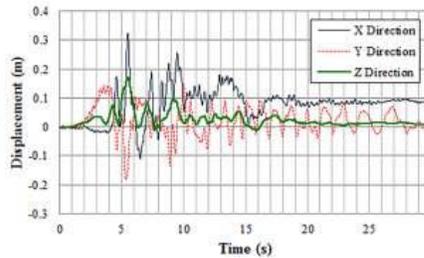
(a) Without seismic retrofit.

(b) With seismic retrofit.

Figure 9. Seismic response behaviour at Point C during a strong earthquake ground motion.
