TIME REDUCTION DURING RESTORATION OF THE EXTERIOR OF A HISTORICAL BUILDING

RENATO LAGANA

DARTe, Università Mediterranea di Reggio Calabria, Italy

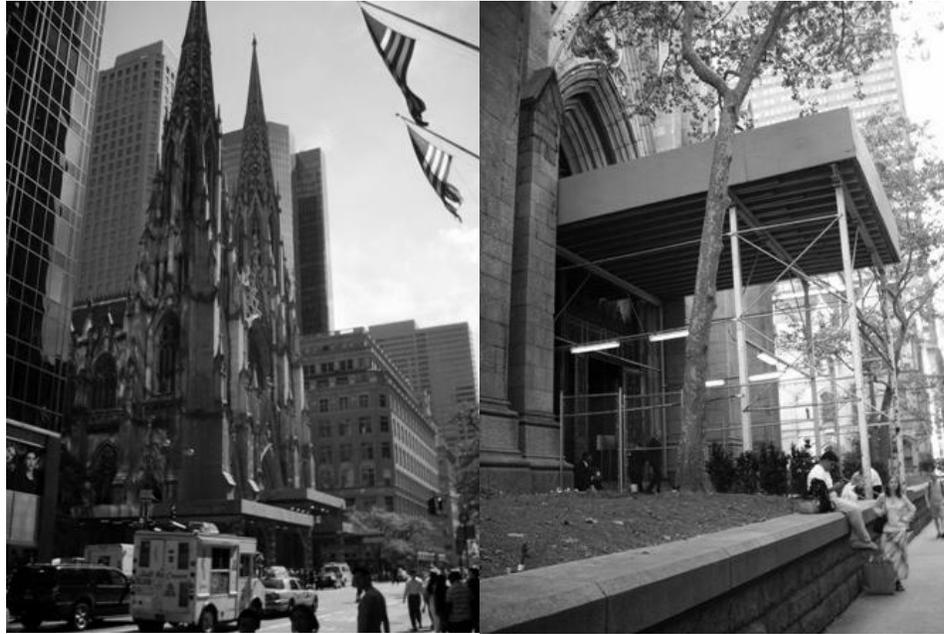
Figure 1. Works provisional after the collapses of architectural elements in the St. Patrick's Cathedral in New York (2011).

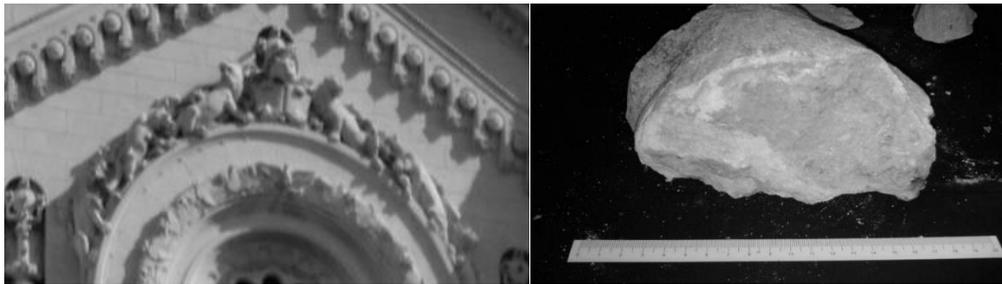
Figure 2. The large fragments that collapsed were the head of a lion decoration that overhung the rose window.

The collapse of a decorative element of the facade of the Cathedral of Reggio Calabria, on the evening of September 6, 2011, motivated the testing of the above. The Fire Department immediately intervened, and inspected the architectural parts and the decorations placed on the top of the facade. They got worried by the cracks and superficial lesions, thus proposing immediate removal. The architect of the Cathedral was opposed to the removal of unsafe parts. However, to facilitate the removal, firefighters fenced the churchyard and the other nearby properties.

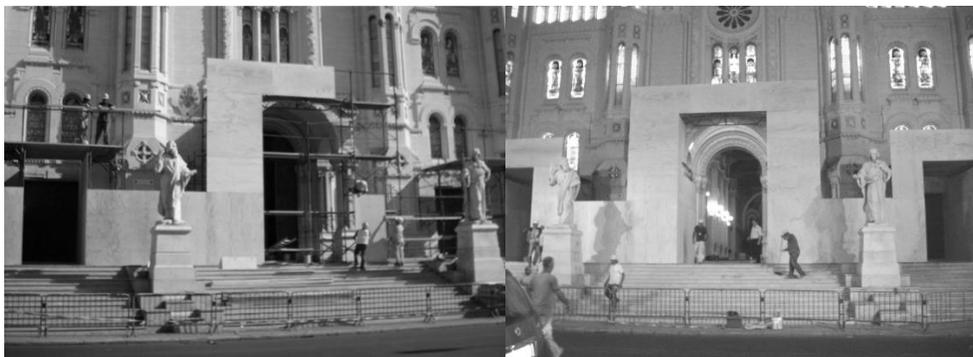
Figure 3. State of work at noon and late evening.

By mid-morning, the work progressed regularly. However, by noon, the work was behind schedule. Other work units received advanced information on the tasks assigned, and reinforced the teamwork. The work was directed to ensure safety in the narrow space of the site. At 10 pm, the teamwork concluded processing and dismantled the fence of the yard, rehabilitating the spaces of the churchyard. Following up the next morning, information was given to the holders of the launches on how to safely access the central passage. At midnight, the heavy launches were carried by over a hundred devotees, and they entered the Cathedral. A large flow of worshipers used the apertures protected to enter the temple.

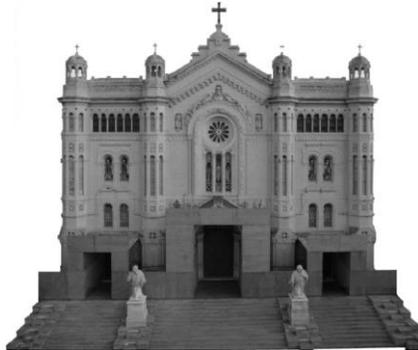
Figure 4. The provisional structure built to protect the entrances.

The pending program of a religious solemnity (scheduled three days later) compelled the organizers to launch a plan of action to implement the protection of access to the temple. The Technical Office Diocesan drew up the plan of remedial measures specifying the procedures for implementation and the necessary safety measures. The next morning they inspected, with the officials of the Architectural Heritage, the confirmed that operations could start safely. They provided for the protection of access to the building, using temporary works. To secure access to the Cathedral (the central door and two side doors), a structure was designed consisting of two levels of scaffolding trestle covering the wooden plates and topped by a thick plank.

The provisional structure protected the doors of the Cathedral for over a year. It also ensured the execution of an accurate survey of the damage on the facade of the Cathedral to formulate a correct restoration project.
