REPAIR OF CORRODED RC BEAMS

Twelve prototype rectangular RC beams (120 x 150 x 1000 mm) were constructed and evaluated using flexural test to investigate the employment of advanced composites in repairing corroded reinforced concrete (RC) beams. Three concrete mixtures with effective w/c ratio of 0.4 and cement content of 370 kg/m³ were utilized in the study: control ordinary Portland cement concrete, silica fume (SF) and ground granulated blast furnace slag (GGBFS) concrete mixes. The RC beams (reinforced with two steel bars having diameter of 12 mm) were immersed (after 28 days of curing) in 2.5% NaCl solution and exposed to accelerated corrosion process using impressed electrical current. The corroded RC beams were repaired using advanced composite of carbon fiber reinforced polymer (CFRP) sheets. The CFRP sheets measuring 300-mm width by 0.131-mm thickness were used to rehabilitate and restore the mechanical behavior of the corroded and damaged RC beams. The investigation results confirmed that the corrosion of steel reinforcement caused significant deterioration and reduction of flexural capacity. The corroded SF and GGBFS beams showed higher flexural capacity compared to the

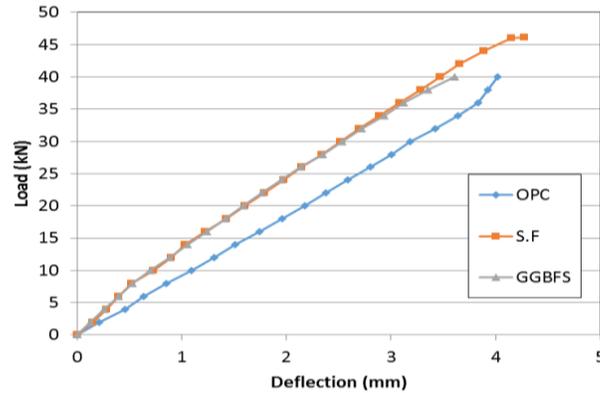
Figure 1 shows the load-deflection behavior of the intact RC beams before exposed to corrosion. As shown in the figure, both the SF and GGBFS reinforced concrete beams showed higher flexural capacity performance compared to the OPC beams. The stiffness of the SF and GGBFS beams increased significantly compared to that of OPC

beams. Also, the SF beams reached higher ultimate load of 46 kN compared to the GGBFS that reached 39 kN and the OPC that reached 40 kN which is about 1.15 times the results of OPC and GGBFS. This behavior may be due that the SF concrete has higher 28 days compressive strength (42 MPa) compared to that of the OPC concrete (30 MPa) and GGBFS concrete (24 MPa). Both the OPC and GGBFS reached almost the same ultimate maximum load. The SF beams were also more ductile and reached higher ultimate deflection of 4.3 mm compared to 4 mm for the OPC and 3.6 mm for the GGBFS beams.

Figure 1. Load-deflection behavior for the RC beams before corrosion.

1. Both the SF and GGBFS reinforced concrete beams showed higher flexural capacity performance compared to the control beams. The stiffness of the SF and GGBFS beams increased significantly compared to those of the control beams.
2. The GGBFS beams showed the highest performance to corrosion with 33% reduction in the ultimate load, then the SF beams with 48% reduction. The control RC beams had 50% reduction in the ultimate flexural load capacity.

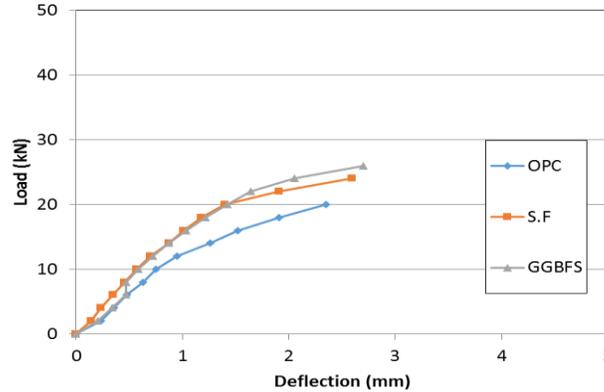
Figure 2. Load-deflection behavior for the corroded RC beams.

Figure 2 shows the load-deflection behavior of the corroded RC beams under flexural loading test. It is obvious that the RC beams containing SF and GGBFS showed higher performance to corrosion compared to the OPC beams. The ultimate load of the GGBFS and SF beams reached 26 and 24 kN, respectively, compared to 20 kN for the OPC beams. The percent reduction in the ultimate flexural load capacity for the OPC, SF and GGBFS were 50%, 48% and 33%, respectively. The use of 60% GGBFS replacement by cement concrete improved the performance of RC beams against

corrosion compared to the OPC and SF concrete. The superiority performance of GGBFS in resisting the corrosion of reinforcing steel may be explained that the GGBFS particles effectively bind the chloride ions that initiate the corrosion of the steel bars.

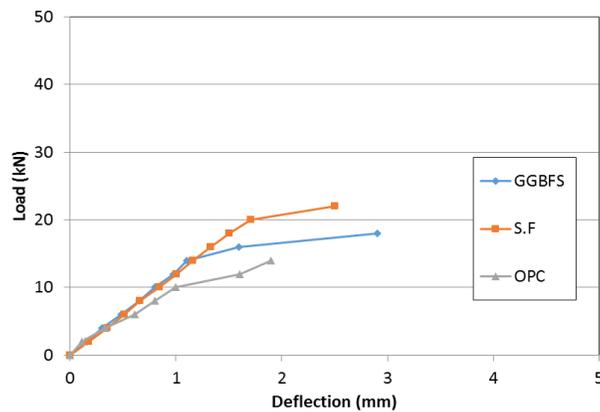
Figure 3 presents the load-deflection behavior of the repaired beams. The RC beams containing mineral admixtures shows higher ultimate flexural load capacity compared to the OPC beams. The ultimate load capacity of the SF and GGBFS beams were 22 and 18 kN compared to 14 kN for the OPC beams. The GGBFS beams showed the highest deflection value of 3 mm compared to 1.9 mm for the OPC beams and 2.5 mm for the SF beams. The repaired SF and GGBFS beams showed higher ductility compared to the OPC beams. The SF beams exhibited the highest ultimate flexural load of 22 kN with percent gain of 48% from the intact original flexural load (before corrosion and deterioration) compared to 18 kN ultimate flexural capacity for the GGBFS with percent gain of 45% and 14 kN for the OPC with percent gain of 35%. The repaired SF and GGBFS beams showed higher performance gain in the flexural capacity compared to the repaired OPC beams.

Figure 3. Load-deflection behavior for the repaired RC beams.

3. The rehabilitated SF and GGBFS beams exhibited higher ductility and flexural capacity gain of 48% and 45%, respectively, compared to the rehabilitated OPC beams that gained 35% of the ultimate flexural load capacity.
