MATERIAL AND OUT-OF-PLANE FLEXURAL PROPERTIES OF TRADITIONAL MASONRY WALL

NORIKO TAKIYAMA¹, AKARI YAMAGUCHI¹, KOHEI HARA¹ and VERDEJO JIMENEZ, JUAN RAMON²

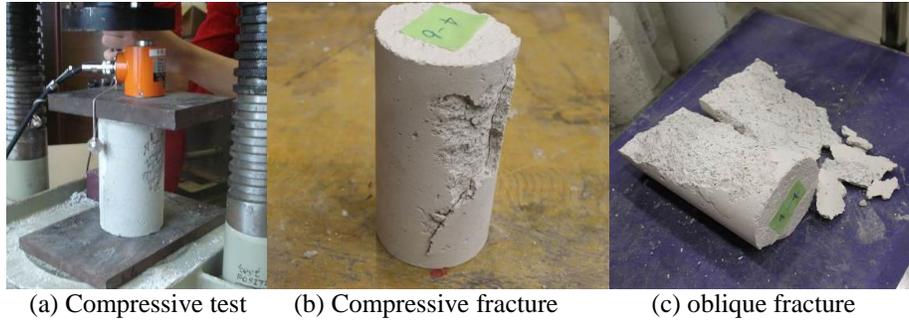
Figure 1. Compressive test and main fracture.

Material tests were conducted based on JIS A 1108 and JIS A 1113. The compressive strength test and splitting tensile test and main damage are depicted in Figures 1 and 2. The strength of each cylinder is illustrated in Figure 3, excluding cases containing cement. Because the strength of the cylinders with cement were found to be twenty times that of cylinders without cement, the results with cement were excluded from this paper.

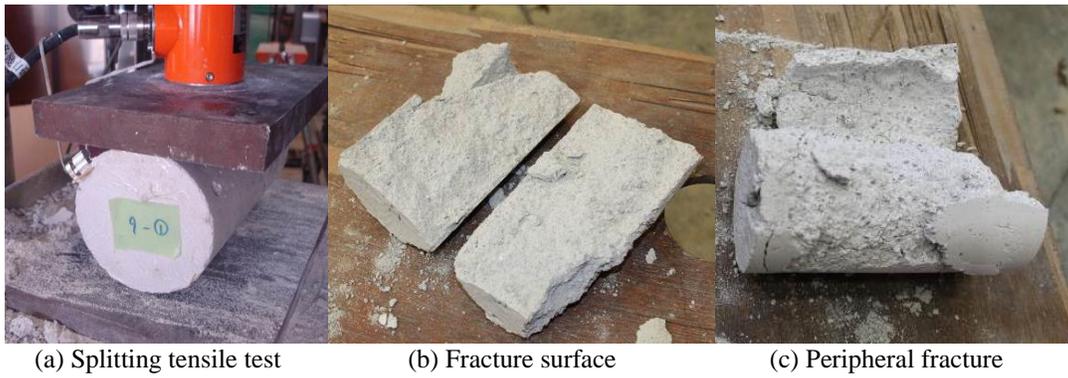
Figure 2. Splitting tensile test and main fracture.

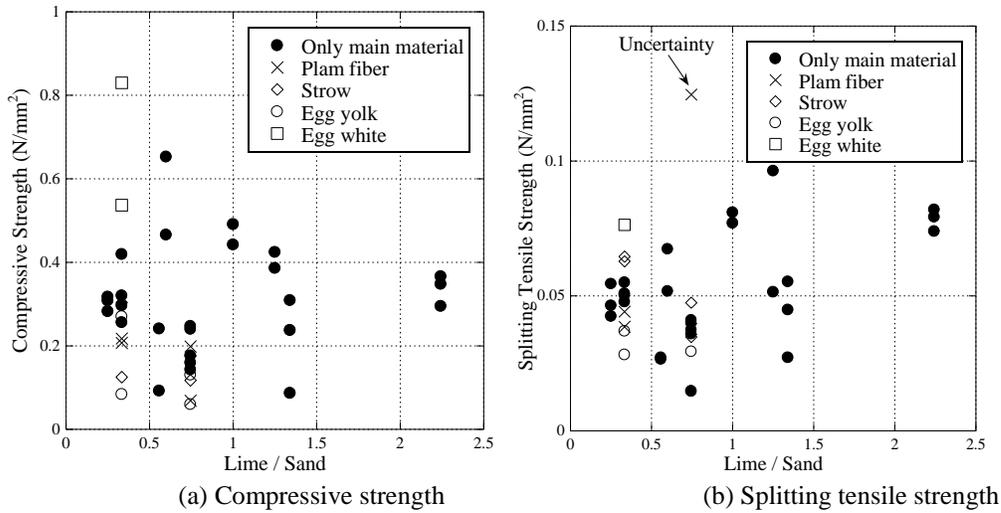
Figure 3. Relationship between material strength and the ratio of lime to sand.

Almost all cylinders were found to be very brittle. The horizontal axis in Figure 3 is the ratio of slaked lime to sand. For compressive strength, the cylinders without additional materials were stronger than contaminated ones, expect for egg white. For the splitting tensile test, the strength increased as the ratio of slaked lime to sand increased up to a value of 1.0, but with high

variation. Furthermore, like the compressive test, the cylinders without additional materials were stronger than ones with contamination, expect for those with egg whites. The strength of the cylinder containing palm fiber was uncertain.

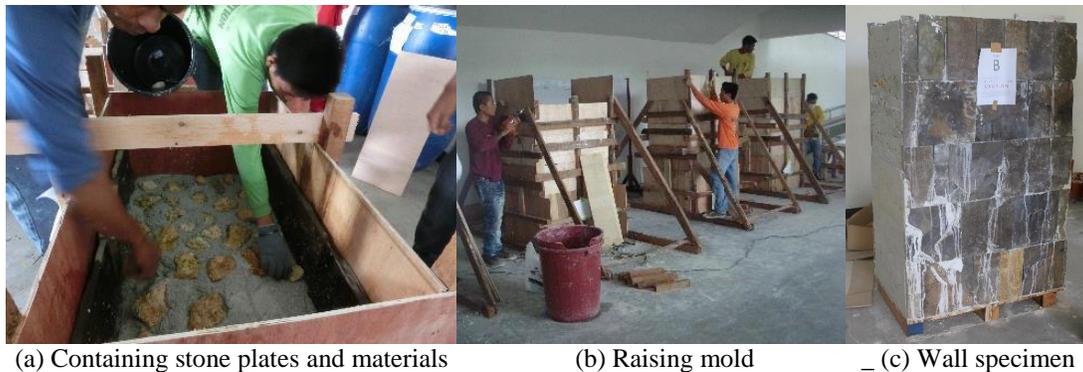
Figure 4. Construction of wall specimens.

We constructed wall specimens A to D as shown in Figure 4. First, we build a raising mold out of timber. Next, coral stone plates were arranged on both sides of the wall. Then, we kneaded the lime mortar, slaked lime, and sand using a mixer. Furthermore, we install knead materials and rock among the stone plates as shown in Figure 4 (a). This same process was repeated five times over as shown in Figure 4 (b). The completed specimen is shown in Figure 4 (c). Additionally, five material test cylinders were made at the same time from the material used to build each wall specimen.

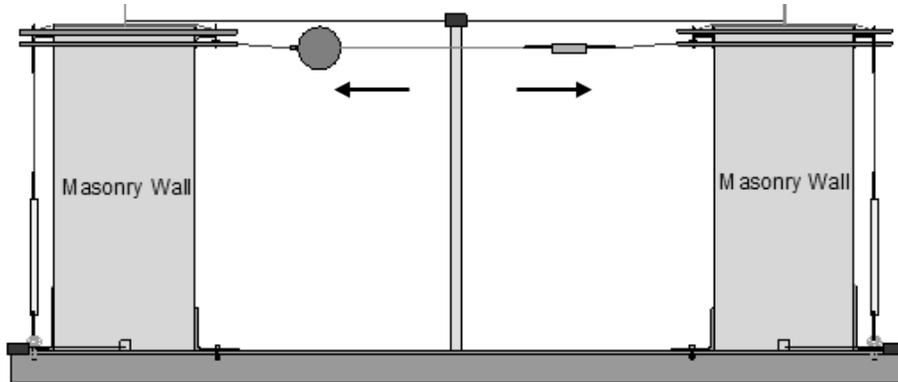
Figure 5. Loading system.

We designed a loading system as shown in Figure 5. Two wall specimens were laid face-to-face of out-of-plane on the steel member, the chain block was used to connect both tops of the walls, and they were pulled against each other. The pulling loads are measured by load cell.

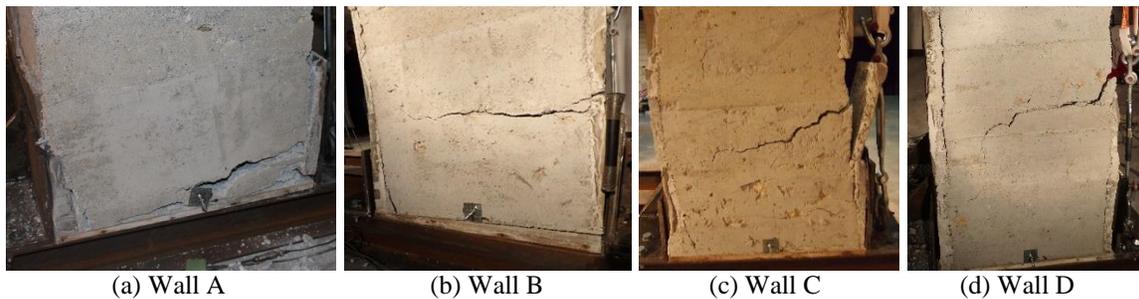
Figure 6. Main damage of wall specimens.

The maximum loads are indicated in Table 2 and the destruction is shown in Figure 6. For Wall B to C, bending destruction was found, but for only Wall A, the foot of the wall was broken, so the maximum loading could not be measured.
