# REMAINING STRENGTH EVALUATION OF PLATE GIRDERS WITH CORROSION NEAR SUPPORTS

NAOYUKI ASAO<sup>1</sup>, KATASHI FUJII<sup>2</sup>, HIROAKI FUKUDA<sup>2</sup>, and RYUICHI YOKOTA<sup>2</sup>

<sup>1</sup>*Pacific Consultants Co., LTD., Tokyo, Japan*

<sup>2</sup>*Hiroshima University, Hiroshima, Japan*

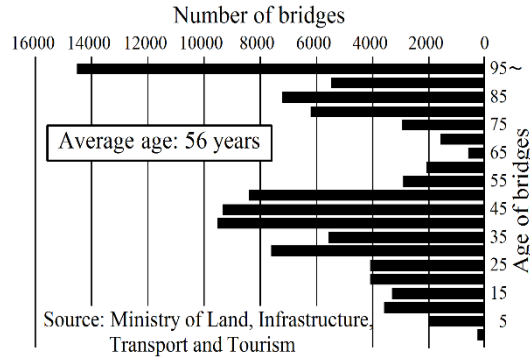
Figure 1. Stock pyramid of existing railway bridges in Japan (As of 2012).

As of 2012, there were approximately 102,300 railway bridges of at least 1 m in length in Japan. Figure 1 shows the stock pyramid which consists of the number of these railway bridges separated by age groups. Of them, steel plate girders are one of the oldest bridges, their corrosion damage due to age deterioration is becoming more obvious. Partial repairs and reinforcement as well as total replacement of girders have taken place in recent years, but it cannot be said with certainty that these measures were selected after a proper, quantitative evaluation of the remaining strength of the girders. In light of recent socioeconomic conditions caused by budgetary and labor shortages, there is an even more pressing need to establish streamlined, economically viable methods for maintaining these bridges into the future.

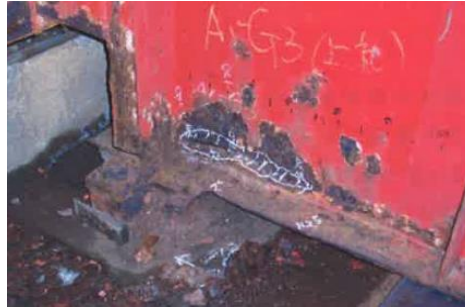
Figure 2. Peeling conditions between webs and lower flanges near supports.

One characteristic of plate girder corrosion is the occurrence of corrosion near supports. The complicated structure of members near supports at girder edges prevents the passage of wind and often limits exposure to sunlight, leading to the pooling of water atop abutments, thus facilitating the progress of corrosion than in other parts. In general, there are many observed cases of corrosion of webs and vertical stiffeners near supports. There are also some cases of peeling at joints between webs and lower flanges due to local corrosion (Figure 2).

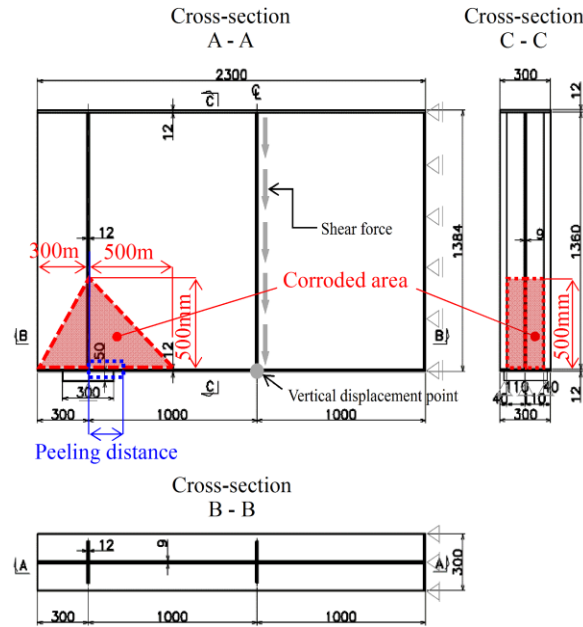
Figure 3. Dimensions of main plate girders targeted for the analysis.

Figure 3 shows the dimension of main plate girders, the target of the analysis. The purpose of this study is to provide evaluations focused on shear capacity, therefore the analytical models are configured such that they account for the symmetry of main girders by applying loads near supports in order to lessen the effects of bending to the extent possible while working with the analytical models. In addition, rigid elements are applied to the supporting sole plate. Shell elements with 4 nodal points are applied to these analytical models, with each element divided into a size of approximately 10 mm (Figure 4). In addition, Figure 5 shows boundary conditions. These analytical models take into account initial imperfections in the out-of-plane direction on the web between the vertical stiffeners. Modeling procedures like these are listed in a reference<sup>1</sup>.

The results of investigation shown in Table 1 have been reported as the main forms of corrosion of plate girders near supports<sup>1</sup>. With reference to the results, the analyses are conducted on the assumption that uniform mean thickness reductions occur within the typical areas of local corrosion of webs and vertical stiffeners as shown in Figure 3. Case studies where remaining shear load bearing capacity is calculated with respect to corrosion location and remaining thickness as shown in Table 2 are analyzed. Furthermore, the same analyses are conducted on cases of peeling of the joints between webs and lower flanges directly above supports (Figure 3).

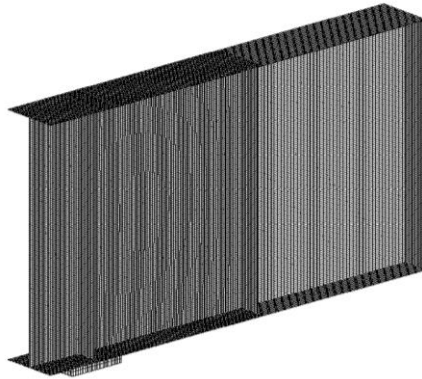
Figure 4. Analytical model.

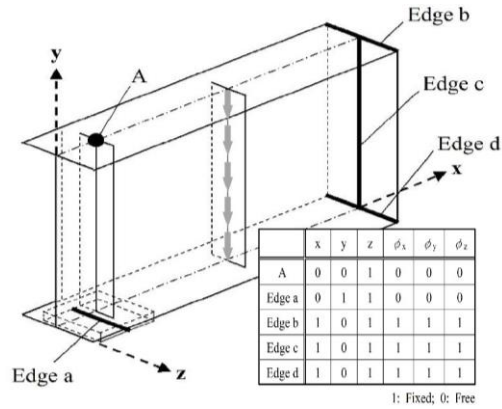
Figure 5. Boundary conditions.

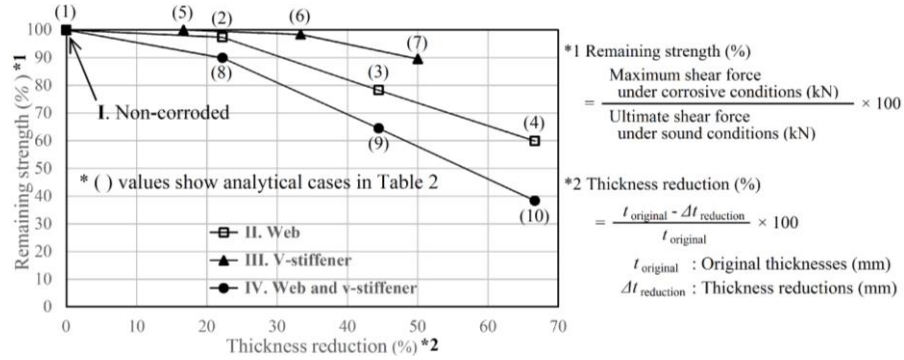
Figure 6 shows the relationship between thickness reduction and remaining strength for models in which only one of webs or vertical stiffeners near supports corrodes, and for models in which they both corrode simultaneously. The figure shows that web corrosion has the largest effect on shear capacity at girder edges. This rapid reduction of strength is caused by the occurrence of local buckling of webs before the shear force is transferred to the diagonal tension field of the webs (Figure 7(a)). The figure also shows that, for the models in which only vertical stiffeners corroded, shear strength reduced only around 10% even when thickness was reduced 50%; the

effect is not very significant. On the other hand, shear strength reduced much more dramatically for the models in which webs and vertical stiffeners corroded simultaneously than for the models in which only webs corroded. This likely has a greater effect on shear capacity than cases where only vertical stiffeners corroded because shear force is intensively redistributed to vertical stiffeners when the corroded parts of webs suffer local buckling.

Figure 6. Shear strength reduction due to corrosion.

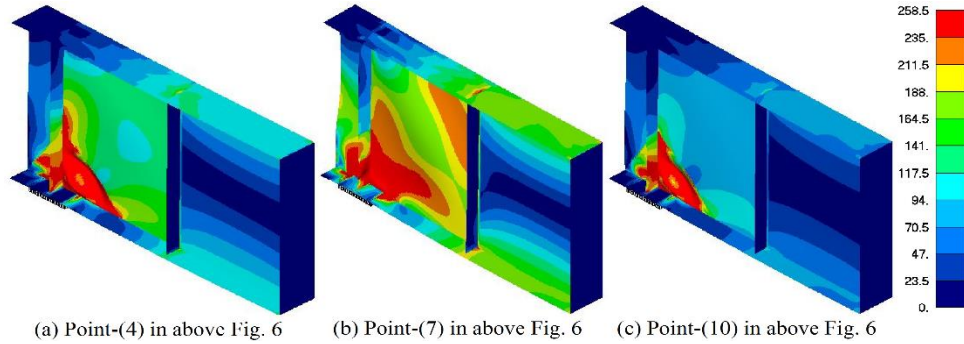
Figure 7. Stress distribution and deformation diagram at maximum shear force (Corrosion).

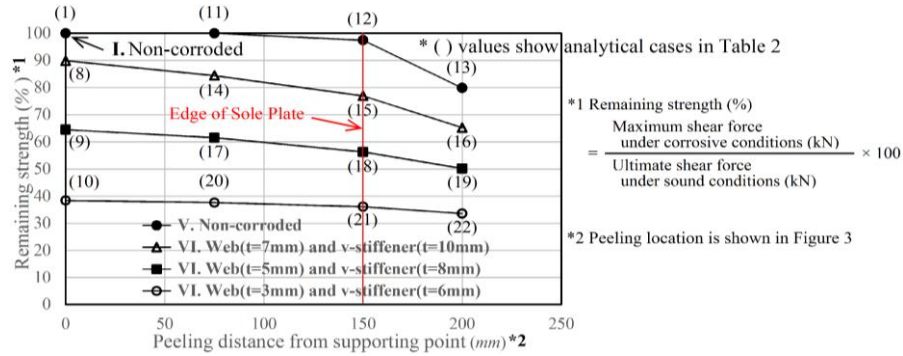
Figure 8 shows the relationship between the distance of peeling from support centers and remaining strength for models in which peeling occurs at joints between webs and lower flanges directly above supports, and for models in which they both corrode simultaneously. In the non-corroded models, shear capacity decreases suddenly when the peeling distance exceeds 150 mm. In addition, deformation stress diagrams of those cases show high concentrations of stress toward the peeling areas (Figure 9(b), (c)). Sole plates exist up to 150 mm from support centers, and if peeling occurs within that area, the webs effectively work as stress transferring mechanism between vertical stiffeners and lower flanges. However, if that function fails once and peeling exceeds that area, stress becomes concentrated on the lower flange and sole plate boundaries, which likely renders lower flanges incapable of withstanding shear deformation. Furthermore, the models show that peelings with local corrosion of webs and vertical stiffeners simultaneously have smaller effects on the strength reduction according to peeling extension as the thickness reduction due to corrosion increases. This is likely because extreme local corrosion near supports causes local buckling at areas with reduced thickness earlier than in peeling areas.

Figure 8. Shear strength reduction due to peeling (Incl. corrosion).

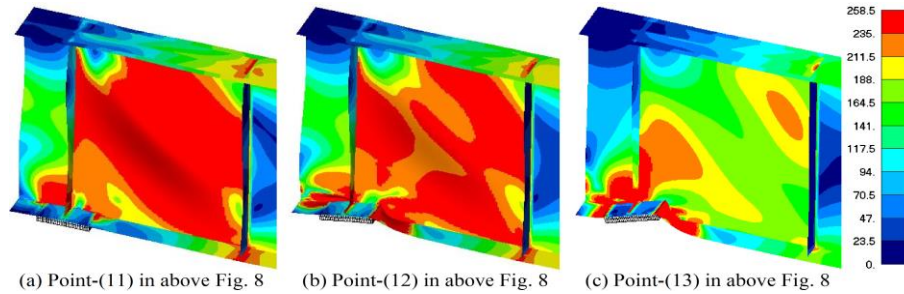
Figure 9. Stress distribution and deformation diagram at maximum shear force (Peeling).
