AN INVESTIGATION OF CORROSION ENVIRONMENT OF A BRIDGE CONSTRUCTED IN MOUNTAINOUS AREA

KAZUTO MARUYAMA and TOSHIHIKO ASO

Dept of Civil and Environmental Engineering, Yamaguchi University, Ube, Japan

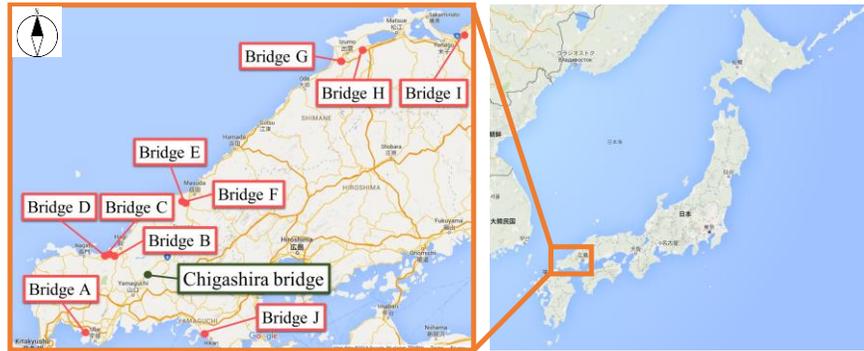
Figure 1. Location of bridges.

On-site observation was conducted at Chigashira Bridge. Figure 1 shows location of the bridge and other steel bridges which constructed in coastal area compare with the bridge. Figure 2 and Figure 3 displays outline of the bridge and Table 1 indicates overview of the bridge. The bridge is located in Ato town, Yamaguchi city, Japan. The bridge length is 60 m, and it is a plate girder bridge with 3 main girders. In Fig 2, main girders of the bridge assumed G1, G2, and G3 from the south side, and strain girders of it assumed S1, S2 from the south side.

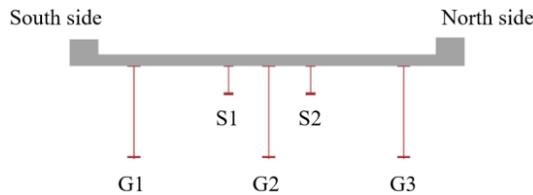
Figure 2. Cross section of Chigashira bridge.

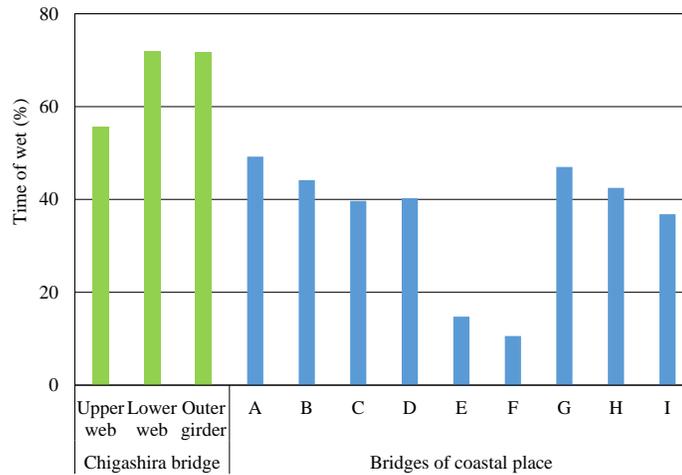
In Chigashira bridge, ratio of time of wet was calculated from temperature and humidity, and Fig.4 shows compared with ratio of time of wet of steel bridges constructed in coastal place (past of the same period). The ratio of time of wet was found by dividing total of measurement time from total of time of wet. The time of wet defined as the temperature at 0°C or more and a humidity of 80% or more of time by ISO.

Figure 4. Comparison of time of wet.

From Fig.4, ratio of time of wet of all parts in Chigashira bridge were bigger than that of steel bridges constructed in coastal place. Figure 5 (a) shows wind rose, and Figure 5 (b) shows wind

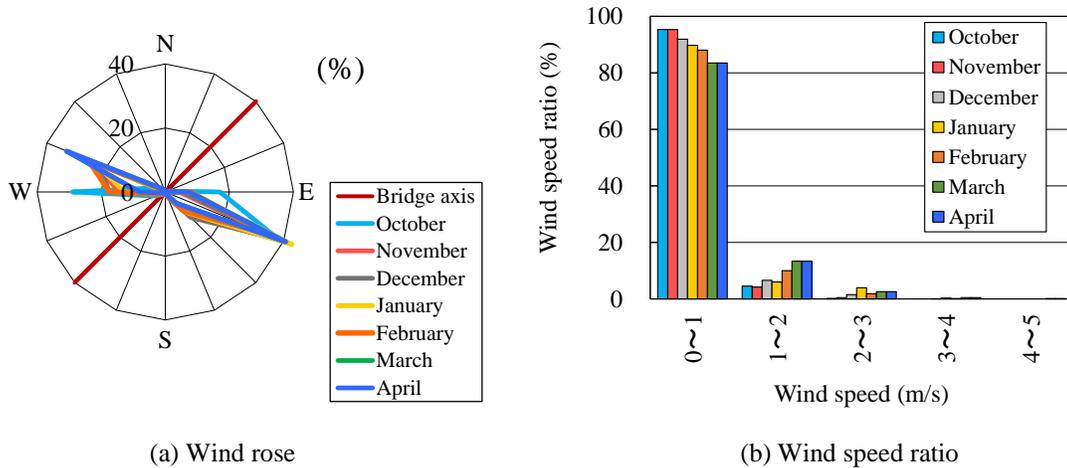
Figure 5. Wind condition of Chigashira bridge area in different month.

speed ratio. From Fig.5 (a), prevailing wind was from east southeast every month. It is bridge axial orthogonal direction. From Fig.5 (b), wind speed has become stronger every month, but wind ratio of 0~1 m/s indicates a more than 80% every month. From, wind conditions of around Chigashira bridge, it can be seen that gentle wind is mainly blowing bridge axial orthogonal direction.

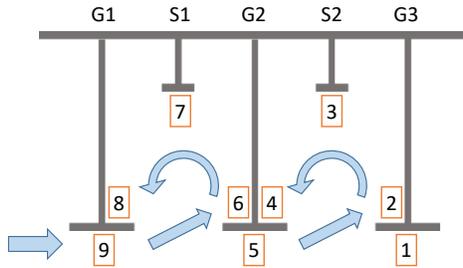
Figure 6. Installation position of dry gauze and the status of inflow wind.

Figure 6 shows the installation position of dry gauze and the status of inflow wind. Fig.7 shows airborne salinity that measured from October, 2015 to March, 2016, and Fig.8 shows transitions of anti-freezing agent and airborne salinity of No.5. From Fig.7, airborne salinity of under the girder (No.1, 5 and 9) and part of inner girder (No2 and 6) increased from December, 2015 to January, 2015. This type of phenomenon is due to the anti-freezing agent. Because from Fig.8, airborne salinity has also increased with the increasing of anti-freezing agent. As a result, anti-freezing agent scattered to the girder. In addition, amount of airborne salt of No.2 and 6, the prevailing wind is affecting. Because prevailing wind blows from the G1 side, and flows into the girder as shown in Fig.6.

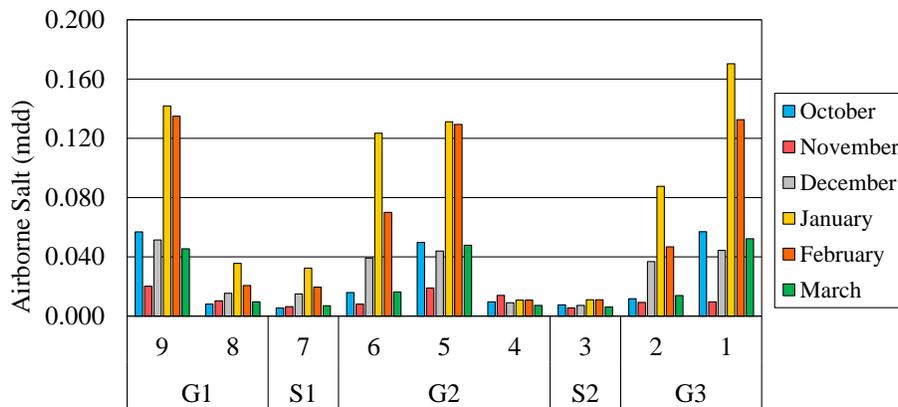
Figure 7. Airborne salinity in different month.

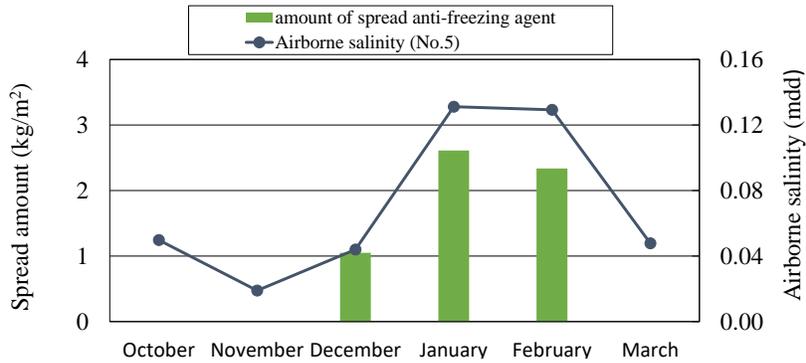
Figure 8. Transitions of anti-freezing agent and airborne salinity (No.5).

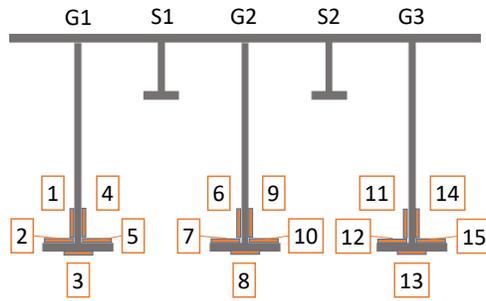
Figure 9. Installation position of exposed specimens.

Figure 9 shows installation position of exposed specimens. Figure 10 shows rust thickness of exposed specimens that measured from October, 2015 to April, 2016. From Fig.10, focusing on exposed specimens of inner girder (No.4, 5, 6, 7, 9, 10, 11 and 12).

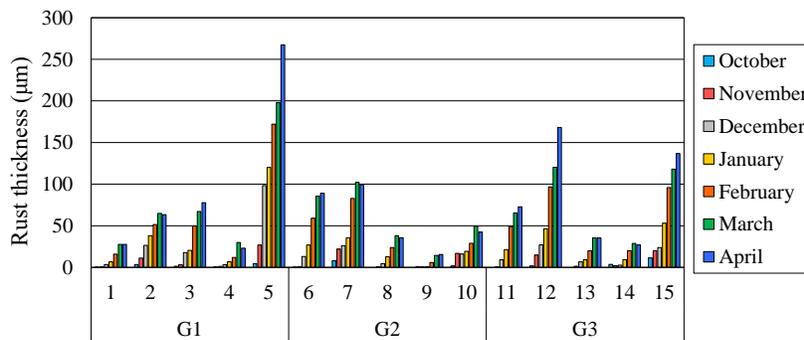
Figure 10. Rust thickness on exposed specimen.

In inner girder of G1G2, rust thickness of No.5 is shown maximum because rust liquid had been deposited in November. But in web, rust thickness of No.6 of susceptible to prevailing wind is more growth than rust thickness of No.4. And in inner girder of G2G3, rust thickness of 11 and 12 of susceptible to prevailing wind were more growth than rust thickness of No.9 and 10. From

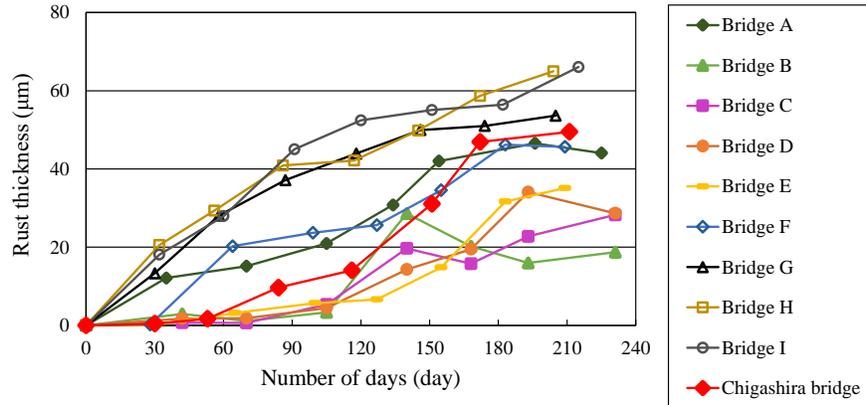
these, rust thickness of inner girder is affected by the anti-freezing agent that scattered by prevailing wind. Figure 11 shows the time course of rust thickness at Chigashira bridge and steel bridges constructed in coastal place in the L.flg lower surface. From Fig.11, rust thickness of Chigashira bridge was bigger than that of Bridge A to Bridge F. This is assumed to be related to the fact that there are more time of wet at Chigashira bridge compared with that of steel bridges constructed in coastal area, and anti-freezing agent scattered to the girder in Chigashira bridge.

Figure 11. Comparison of rust thickness.
