## REHABILITATION OF BOX GIRDER BRIDGE

A large pre-stress continuous box girder bridge consists of two separate parts, ten spans deck and eight spans deck. The bridge was subjected to multiple airstrikes, which caused several damages. The most serious are the complete destruction of four conductive spans in the ten spans deck, the movement of the remaining six spans longitudinally by about 1.25 m and transversely by about 0.1 m. Local damages occurred in other parts of the deck structure and minor damages in the piers and abutments. The deck structures were constructed by incremental launching method (ILM). Rehabilitation of the bridge included repair of the local damages, lifting and reinstatement the six spans, which weighs about 9,000 tons, to its original position, the constructing and launching of new box girder to substitute for missing spans, and finally connecting old and new spans effectively. This paper introduces briefly the reinstatement of the six spans, connection details between the old new structures, then assessing the efficiency of connection by analysis and load testing the connecting span.

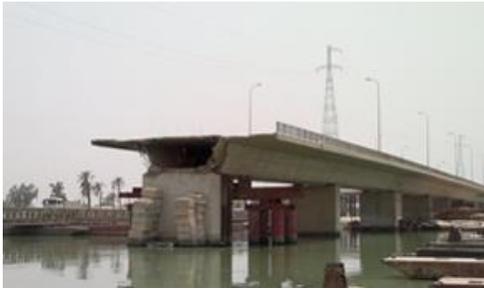
Figure 2. Damages of bridge.

The bridge attacked numerous times during the gulf war. The most serious damages occurred in the east part, where the three eastern spans (S8 to S10) were completely destroyed and span (S7) was completely cut near pier P(2-8). The remaining part of the span acted as cantilever, failed at P(2-7), deflected and pulled the six spans behind it a distance of about 1.25 m. The first span dropped from the bearings and the end diaphragm leaned on pier P(2-1). The six spans are supported on piers P(2-2) to P(2-6) and temporary supports near P(2-1) and P(2-7).

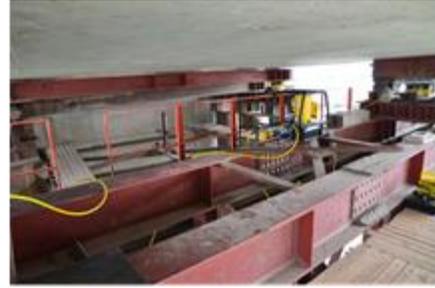
Figure 3. Reinstating original structure.

Two pairs of 500 ton capacity hydraulic jacks were provided at piers P(2-2) to P(2-6) and on one pair at temporary supports near P(2-1) and P(2-7), for vertical lifting. These jacks are supported on secondary steel chairs, which in turn supported on main steel chairs with very low friction pad separating the two chairs. Flat jacks were installed between the two chairs to cause transverse movement of the deck, after transferring the load of the six spans to the vertical jacks. After correcting the alignment of the six spans, the spans were lifted to their design level. Then the old bearings were replaced by new ones, which were designed to allow longitudinal sliding. The longitudinal movement of the six spans was achieved by using prestressing jacks for which special steel structures designed to be fixed to the two stiff diaphragms of the east and west

bridges. The jacks` reaction was on the west diaphragm and the pull force acted on the east diaphragm, moved the six spans toward the west until reaching their final location.

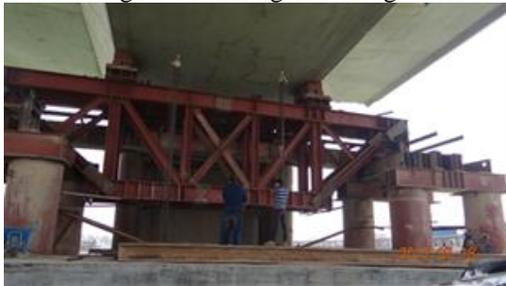
Figure 4. Reinstating original structure.

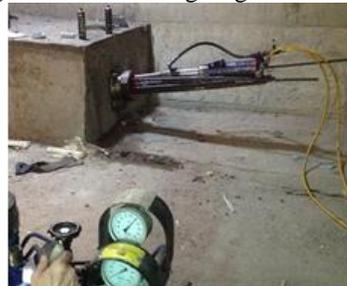
Figure 5. Anchoring old tendons.

Although span six did not show signs that the pre-stressing tendons loosing bond with the surrounding concrete of the box section, special steel anchors (shown in Figure 5) were used to anchor the ends of the tendons near P(2-7). The connection of the two structures is as follows:

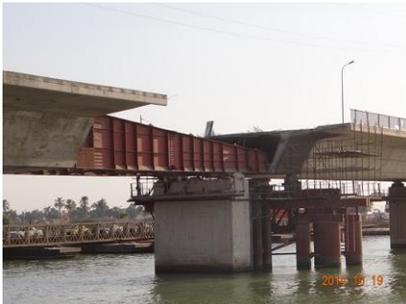
Figure 6. New spans & Launching nose.

- To construct the four new spans, (ILM) starting from east abutment is used. Double steel plate girder launching nose about 30.72m is connected to the face of first increment using 50mm diameter pre-stressing bars grade 1030 MPa.

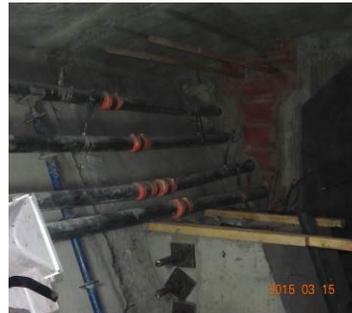
Figure 7. Inside end of new structure.

- In the measured deflections, East point, which is located within the new structure near pier P(2-7), shows smaller deflection than symmetrical point near pier P(2-6). The reason for this is that the end sections of the new structure has much higher rigidity than the rest of the box girder sections due to the increase of the webs thickness to accommodate the launching nose anchor bolts.

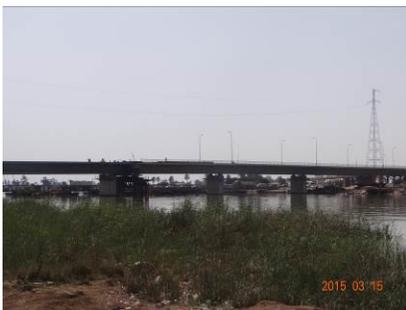
Figure 8. Bridge after connecting both structures.

- The 2 m long segment casted between the two structures. Two blisters were casted with the bottom slab, to anchor one end of two 19T15S bottom tendons, where the other ends were anchored at newly constructed blisters against the diaphragm at P(2-6).

- A special reaction frame was casted 10.82 m from P(2-7) inside the old structure against two already existing blisters on the webs of the old structure. This was used to anchor four prestressing bars near top of the box girder, then two rows of 4-19T15S tendons, one near each web. Each bar was stressed to about 1,500 kN, each of the upper two tendons was stressed to 3,700 kN, while each of the lower two tendons was stressed to 2,650 kN. The other ends of the bars and tendons were anchored at the diaphragm at P(2-7).

- For bottom external pre-stressing, two 19T15S tendons were provided to supply about 7,500 kN pre-stressing force. These tendons improved the resistances to positive moments occur in the middle region of span six and induce required stresses in the interface between the connecting segment and the old structure. To carry this out, six pre-stressing bars (3 on each on side), which were used to connect the bottom of the launching nose were, extended and anchored on the opposite face of the blisters used for the bottom pre-stressing tendons. The six bars induced a compressive force of about 9,000 kN to the bottom region of the east interface between the connecting segment and the new structure. The above system of pre stressing resulted in the following stress pattern:

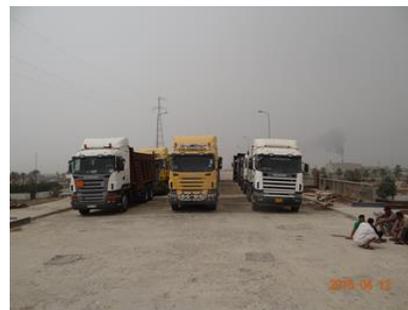
Figure 9. Load Test.

The carriageway width of the bridge is 15 m wide. According to BS5400 P2, four notional lanes should be considered. Two notional lanes shall be loaded by HA-load load of 26.4 kN/m for a loaded length of 40 m in addition to 120 kN knife edge load while the rest shall be loaded with

(1/3) HA load. Therefore, an estimated live load of 412 kN shall be applied. Using 12-350 kN trucks, the total load is 4,200kN. The application of load is done through three stages, where four trucks are added in each stage.

- During load test, the deflection was measured at five points (mid-span, 11, 22 m to the west and east of mid-span).
- The locations of parking of the twelve trucks were marked on the road surface for exact positioning of the trucks during the load test. Then, the trucks were moved to their designated locations, at three stages and deflection measurements were taken by two surveying crews operating from platforms at piers P(2-6) and P(2-7). Readings were recorded after the deck structure was stabilized under each load increment.
- Finally, the trucks were moved outside the bridge in reversed order by three stages. The deflection measurements were taken after the deck structure was stabilized after each stage of unloading. The average values of the two sets of readings were calculated.
