EXPERIMENTAL AND NUMERICAL STUDIES OF STRUCTURAL PERFORMANCE OF NOTCH DAMAGED STEEL BEAMS

SAID ELKHOLY¹ and BILAL EL-ARISS¹

¹*Civil and Environmental Engineering Department, United Arab University, Al Ain, UAE*

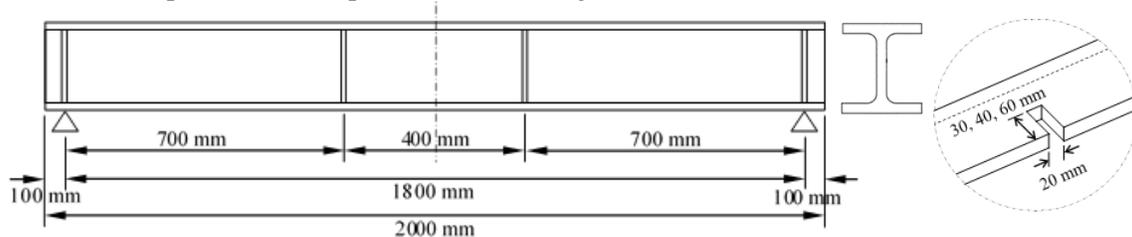
Figure 1. Details of a typical notch damaged I-beam specimen.

A program for testing a total of ten W-shaped steel beams was prepared. One undamaged (control) and nine artificially U-shaped notch damaged beams were instrumented and tested in flexural. The notch was cut in the beam bottom flange and all beams were left unrepaired and laterally unsupported while tested. The notch size was 30 mm, 40 mm, and 60 mm in depth with constant width of 20 mm and was cut on one side of the beam bottom (tension) flange with respect to the beam web. All of the beams had clear span of 1800 mm between the support and a total length of 2000 mm, Figure 1. The location of the notch was at one-quarter, one-third, and middle of the specimen clear span, as shown in Figure 2 for notch at middle of the beam.

respectively, and 46.1 kg/m mass. The beam specimens were web-stiffened to avoid web crippling at the support locations and at the two loading point locations which are 400 mm apart and 700 mm away from supports, as presented in Figures 1 and 3.

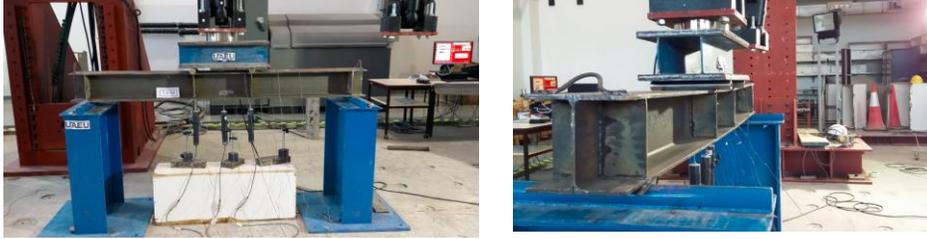
Figure 3. The beams with vertical stiffeners over supports and under loading points.

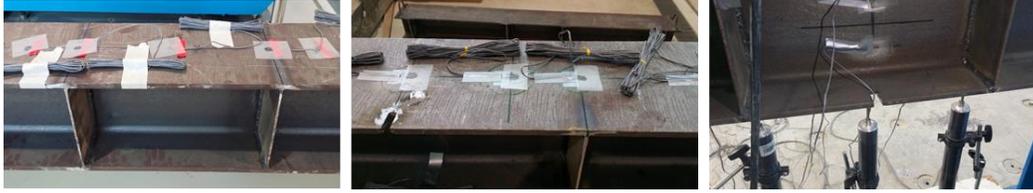
Figure 4. Installation of strain gauges and placement of LVDT's.

The steel W-shaped beams were tested in four-point bending set-up with two point loads applied. The beams had of clear span between the supports of 1800 mm. The two applied point loads were 200 mm on each side of the centerline of the beam and 700 mm from the supports, Fig. 1. The control beam and notch damaged beams were left unrepaired; however, to avoid web crippling of the beams during testing, the beams were web-stiffened with vertical stiffeners under the load application points and above the supports. All steel beam specimens were loaded in a displacement-control mode at a rate of 2 mm/min and were kept laterally unsupported during testing, Fig. 2 and 3. The beam were equipped and instrumented with strain gauges, for strain readings, and Linear Variable Differential Transformers (LVDT), for deflection measurements. The strain gauges were bonded to the outer surface of top and bottom flanges and the web of the beams at locations. The LVDTs were located below the bottom flange at the load application points and at centerline of the beam, as shown in Figure 4.

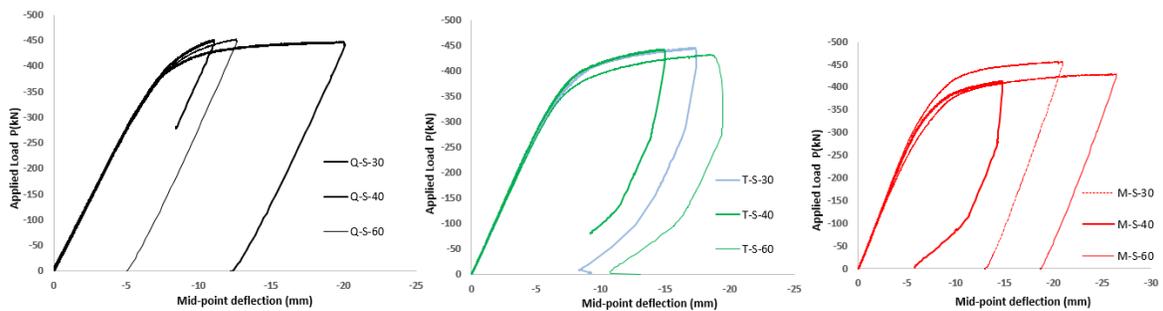
Figure 6. Load-deflection curves.

Figure 6 presents the experimental load-deflection relations of the three groups of the beams, Q, T, and M separately. The figure shows that group Q specimens had the same stiffness regardless of the notch size. Group T specimens demonstrated a slight decrease in the specimen stiffness as the notch size increased due to notch location. Group M revealed more noticeable decrease in the beam stiffness as the notch location had more impact. However, the ductility of the three group specimens had the same pattern where the largest ductility was for the highest notch size, 60 mm.

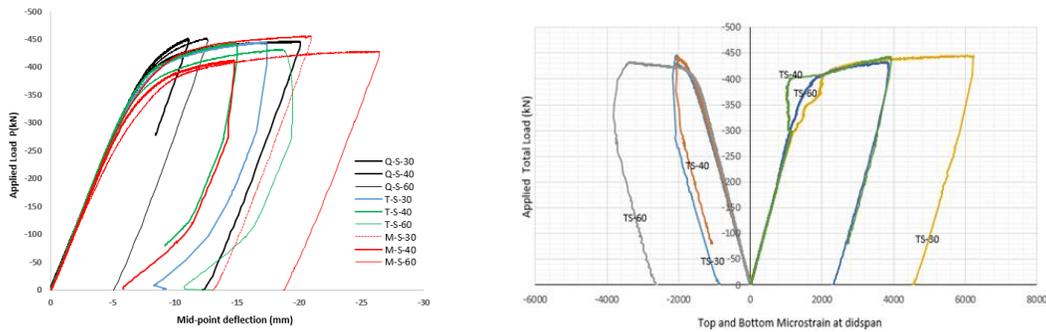
Figure 7. (a) Load-deflections of all beams, (b) load-strain curve for TS-30, 40, and 60 specimens.

Figure 7(a) depicts the experimental load-deflection relations for the tested beams. It can be seen that when the notch was at quarter of the span, the beam had the highest load carrying capacity and the least ductility. When the notch was at third span of the span, the beam load carrying capacity decreased while the ductility increased. The beam had the highest ductility when the notch was at the mid-span but the load carrying capacity was the least. This can be attributed to the beam failure mode as a result of the notch location. More specifically, when the notch is at furthest location from the beam centerline (quarter of span), the beam the beam prematurely twisted at low deflection value. On the other hand, when the notch was at the mid-span, the beam was able to sustain more deflection due to beam symmetry effect until lateral torsional buckling occurred. The beam behavior was somewhat in between the latter cases when the notch was at third of the beam span. Figure 7(b) shows the load-top and bottom strain relationships of group T specimens.

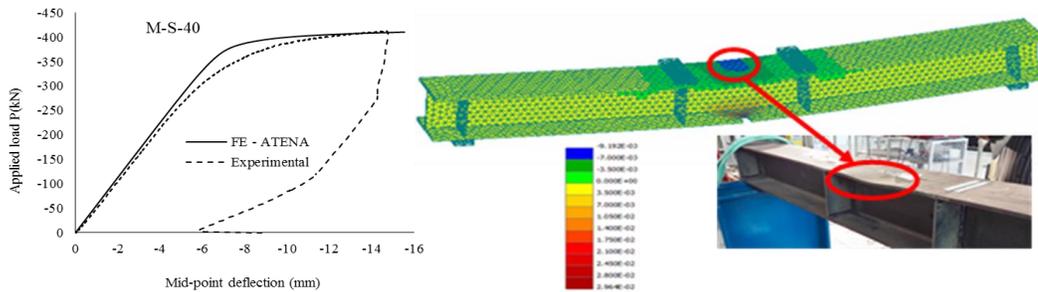
Figure 8. Comparison of FE analysis and experimental results and buckling in specimen M-S-40.

Figures 8 shows the finite element deflection of specimen MS-40. It is clear that the beam numerically predicted behavior matched the beam experimental behavior in terms of buckling failure and location. Both numerical and experimental buckling occurred in the back top flange of the beams simultaneously with plastic deformation arose in the front notch in the bottom flange.

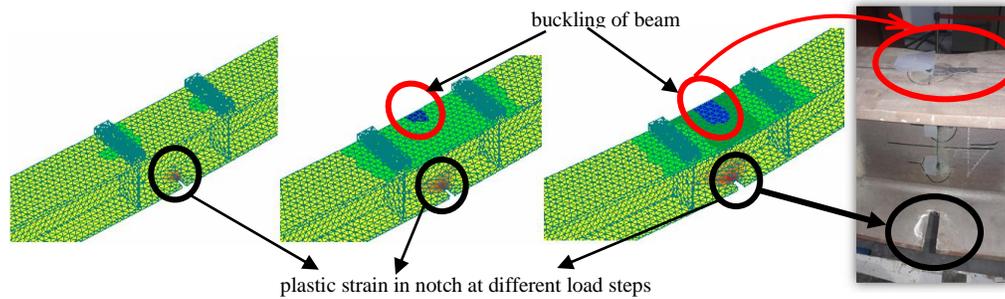
Figure 9. Plastic strain in notch at different loading step and buckling in specimen MS-40.

Figure 9 shows the numerical plastic strain in the notch at different loading steps of the test and failure buckling in specimen MS-40. It is obvious from the figure the numerical buckling failure predicted was in agreement with observed experimental. This confirmed the predicted numerical buckling failure. The test results; therefore, verified the accuracy of the numerical simulation of the tested beams generated in this study. Also, both experimental and numerical outputs showed the same pattern of plastic strain occurring in the notch in the front bottom flange buckling arising in the back of the top flange of the beam.
