ANALYSIS OF HAGIA SOPHIA USING NONDESTRUCTIVE MEASUREMENT

TAKASHI HARA¹ and KENICHIRO HIDAKA²

In this paper, the structural behavior of Hagia Sophia was analyzed by use of vibration records of the structure. The vibration records were measured by the micro tremor meters. The recorded data was utilized not only to define the mode shape but also to evaluate the structural problems. Firstly, the vibration characteristics of the main building were analyzed by combining the vibration records. Secondary, the deformation characteristics and the structural functions of the second cornice were investigated in the same manner as the main building. In case of main building, from the frequency domain analyses, the natural frequency of the main building was analyzed and the obtained natural frequencies were compared with the results of the previous researches. The vibration modes were investigated as well. From these results, the characteristics of the total structure were clarified and the structural problems were detected. In case of the second cornice, the base at the corner where was the junction of the main pier and the sub-dome connecting to the semi-dome showed the movement of the embe

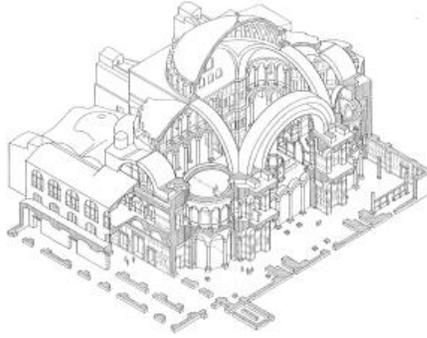
Figure 2. Structure of Hagia Sophia (Mainstone 1988).

The building has been attacked by the strong earthquake in several times and by the penetration of the water and moisture. Therefore, several problems, such as cracking of the walls and the domes, inclination of the columns and water penetration, are detected.

In addition, due to the different depth of the bed rocks and the large deformation of the materials, the building structure shows a lot of damages on the surfaces and represents the incredible structural deformation. To restore and to conserve such a huge heritage structure, the detail structural inspections are required.
