# VIBRATION PROPERTIES OF TRADITIONAL MASONRY WALLS OF CORTES CHURCH

The Santo Niño Church in Bohol Island was partially damaged in the Bohol Earthquake in October 2013. In this study, we investigated the structural property of the Santo Niño Church to understand the vibration characteristics of Philippine masonry constructions by checking the main damage and conducting measurement surveys and microtremor measurement on the structure and ground. The major findings of this study can be summarized as follows: (a) Collapsed walls, peeling wall stone, corner deformation, and collapsed ceiling were the main damages that were observed. The collapsed wall was measured, and the make-up and material thickness of the wall was verified. (b) By performing microtremor measurements on the walls, the vibration property of the church, such as the natural frequency and vibration mode of the longest wall A was clarified. The 1<sup>st</sup> natural frequency of the longest wall A is the lowest.

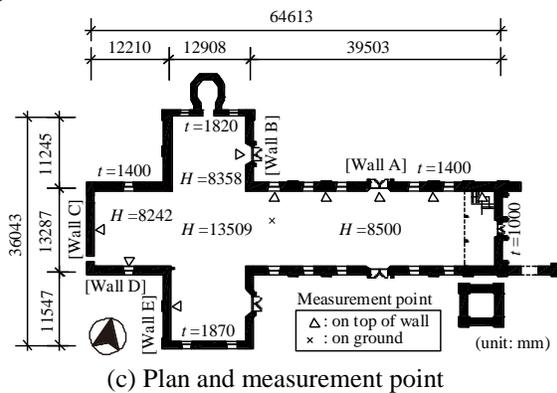
(c) Plan and measurement point

as shown in Figure 2 (c) and Table 1. Then, estimated values of the nearest wall, as shown in ‘( )’, were used as thickness value for walls whose thickness could not be measured.

We conducted microtremor measurements on the walls to clarify the vibration property of the church. The measurement was performed at several points on the top of walls, A–E, as shown in Figure 6. In Figure 2 (c), the measurement points are marked by triangles. The simultaneous measurement was conducted at multiple points by installing one velocity sensor on the ground and some sensors on the wall. Five sensors were installed at wall A to understand the vibration mode. Then, the Fourier spectral ratio is defined as the Fourier spectra on the wall divided by on
