INVESTIGATION OF DAMAGE OCCURRED ON DERBENDIKHAN DAM DURING EARTHQUAKE EXCITATION THROUGH FINITE ELEMENT ANALYSIS

CAGRI MOLLAMAHMUTOGLU¹ and IDRIS BEDIRHANOGLU²

In this study, the performance of a damaged dam was evaluated through a three-dimensional finite element model. The dam is located in Derbendikhan city of Northern Iraq and damaged during a 7.3 magnitude earthquake which was happened 30 kilometers south of Halabja city. Derbendikhan dam which was built between the years 1956-1961 is a clay-core rock fill dam. The damage of the dam was investigated at the site right after the earthquake and some cracks were observed in the main body of the dam. The main goal of this work is to present the results of the survey which was conducted at the site and investigating the damage development mechanism through a realistic three-dimensional finite element model of the dam. As complying with the observations at the site, the finite element analysis has shown that the primary failure mechanism is due to the separation of the core and rock fill sections at the downstream side of the dam.

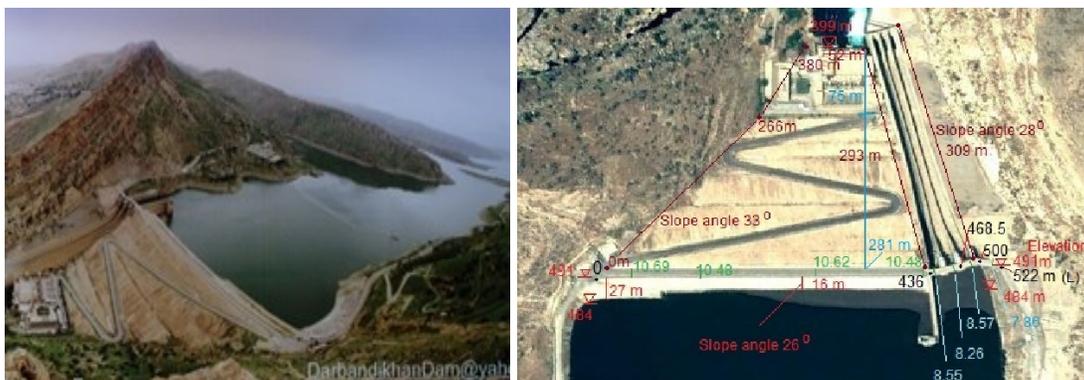
Derbendikhan (Derbendixan) dam is located inside a narrow valley near Derbendikhan district along north-northeast direction (Figure 1). Derbendikhan district in turn is located at the near south of Suleymaniyah province. The 535 m long dam is constructed on a thick limestone layer which is split off deeply by the streams feeding the reservoir and which sits on an alternate formation of mudstone and silt stone. It was constructed between the years 1956-1961 as a rock fill dam with a clay impermeable core. It has a height of 128 m and has a reservoir capacity of 3 billion m³ (Figure 1). Lack of information required to obtain data from open sources and as a result geometrical data were measured from Google Earth as seen in Figure 1 left side. The exact dimensions of the clay core are unknown and assumptions made on the slope and bottom width of the core sections.

Figure 1. Close-up view of Derbendikhan Dam view from right bank and geometrical dimensions.
