APPLICABILITY OF A NEW SURFACE PREPARATION METHOD FOR STEEL STRUCTURE USING LASER

HIROSHI OGAMI¹, KATASHI FUJII², YUKIO MANABE³, KOHEI OTA⁴ and ASUO YONEKURA⁵

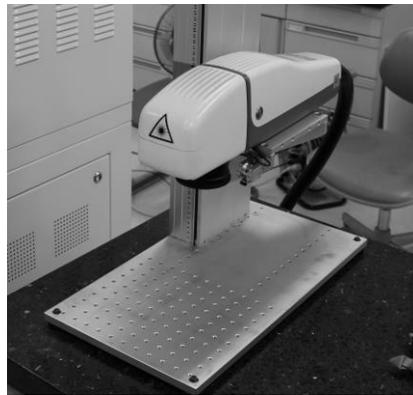
Figure 2. Appearance of the laser marking device.

Figure 1 illustrates the rust condition of the specimen. Laser cleaning was conducted by laser marking device to the specimens. Summary and appearance of the laser marking device are shown in Table 3 and Figure 2. Laser irradiation range is rectangular 40mm by 20mm, and the initial setting of laser at the time of cleaning is the moving speed of 1.0mm/s and the heat input of about 1.3j/mm². In addition, each specimen has changed the frequency for each No.1=30kHz, No.2=50kHz, No.3=100kHz. We irradiated with a laser several times at the same range of each specimen, and the test was terminated when the rust on the surface cannot be confirmed by eyes.
